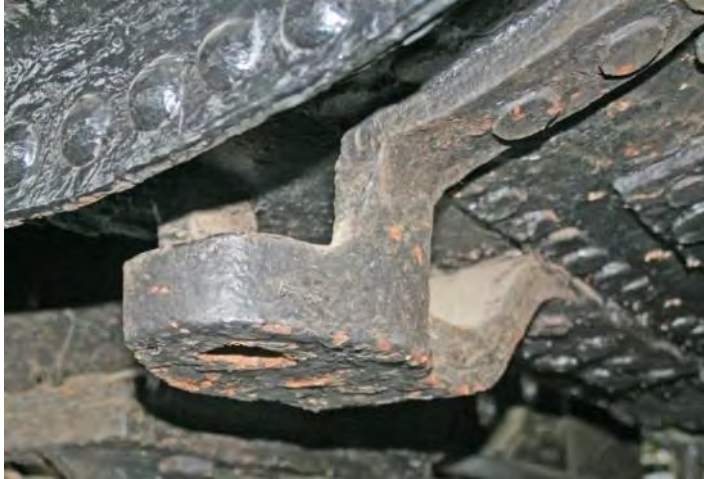
The front drawbar is a heavy-duty iron forging, with two 'wings' and a 'tail' riveted to the boiler barrel.

Fig. 13.5. Front drawbar with wings and tail.

These are all dog-legged to leave the top face around the eye of the drawbar some $3\frac{1}{2}$ in below the boiler barrel.

The drawbar is $39\frac{1}{2}$ in long overall, the rectangular tail being 20 in long and 5 in wide. It is fixed to the boiler plate by eight 1 in rivets. Its dog-leg curve is $4\frac{1}{2}$ in wide and 2 in thick. The wings, which measure $23\frac{1}{2}$ in from tip to tip, are 3 in wide and 1 in thick, each fixed to the boiler by three 1 in rivets over a 10 in length. The material round the drawbar eye is 2 in thick and the eye has worn to an oval $1\frac{1}{2}$ in wide and $1\frac{3}{4}$ in long.

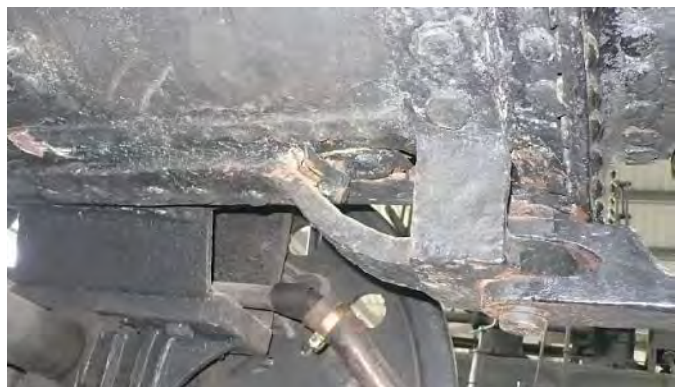
Fig. 13.6. Rear drawbar with tail and wings, together with drawbar pin and coupling.

The rear drawbar seems to be a replacement for an earlier version, a line of redundant 1 in rivets alongside the surviving drawbar tail being evidence of this. The surviving drawbar is similar to the front one. Its total end to end length is 34 in. The tail is 19 in long, 4 in wide and 1 in thick, fixed to the underside of the boiler barrel with a single line of five 1 in rivets. Its dog-leg curve is 4 in wide and $1\frac{1}{4}$ in thick and leaves the top face around the eye of the drawbar $4\frac{1}{2}$ in below the boiler barrel. The wings have a tip-to-tip measurement of $44\frac{1}{2}$ in, and are 4 in wide x 1 in thick, each fixed to the barrel by four 1 in rivets over a 14 in length. The material round the drawbar eye is $1\frac{1}{2}$ in thick, the eye being $1\frac{1}{2}$ in diameter.

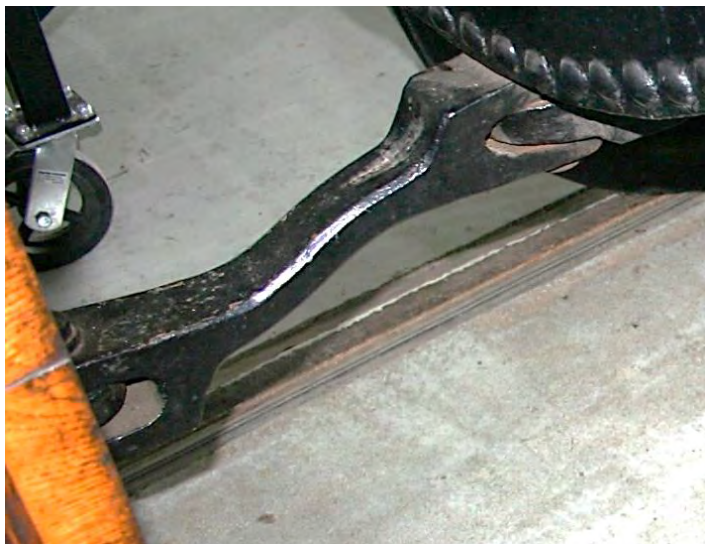
The rear drawbar is fitted with a wrought iron coupling to the tender. This coupling is bent into a shallow 'S' shape and has a clevis at each end to fit with the drawbars on the locomotive and tender. The leading clevis is 6 in long and 3 in wide, increasing to $3\frac{1}{2}$ in around the pin eye. The clevis gap is $1\frac{1}{2}$ in and clevis arms are 1 in thick. The rear clevis is $5\frac{1}{2}$ in long and 3 in wide. The clevis gap is $1\frac{3}{4}$ in and the clevis arms are 1 in thick. The coupling is 21 in long, $2\frac{1}{2}$ in wide and $1\frac{1}{2}$ in thick, with the eye centres $17\frac{1}{2}$ in apart. The coupling pins are $1\frac{3}{8}$ in diameter.

Fig. 13.7. Coupling between locomotive and tender

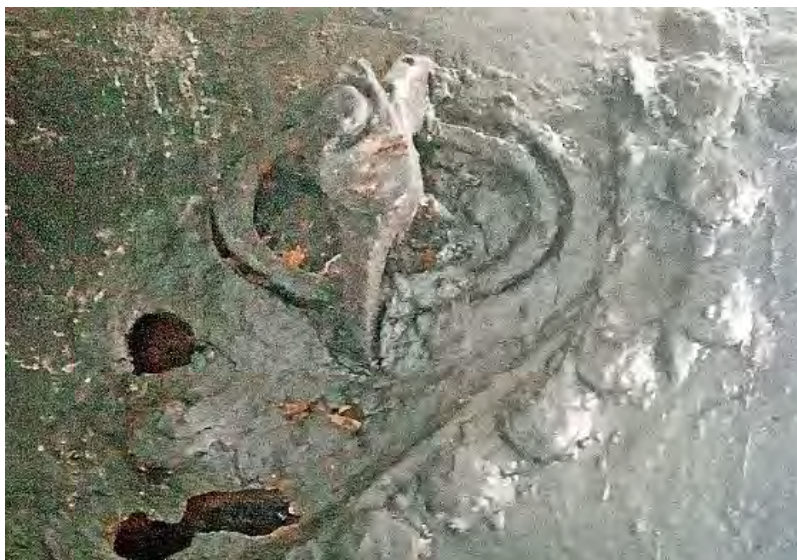
A mud-hole opening is fitted into the bottom of the boiler at approximately mid-length but some $5\frac{1}{2}$ in to the right of the centreline. It is oval with a maximum length of $5\frac{1}{2}$ in and a maximum width of $3\frac{1}{2}$ in. The closure measures about 5 in by 7 in at its internal rim and is retained in place by a bridge of some $5\frac{1}{2}$ in span, secured with a $\frac{1}{2}$ in nut.

Fig. 13.8. Mid-boiler mud hole closure. Front of boiler to the right in this view. Significant corrosion has taken place in the surrounding area.

The boiler was only seven years old when fitted in 1834, and only thirteen or fourteen years old when *LOCOMOTION* was taken out of service. As the boiler was steamed both in 1846 and between 1850 and 1856, it seems likely that the repairs were undertaken during or after the lengthy period when the locomotive was displayed in the open air (Section 8). Despite these patch repairs, there are now holes around the mud-holes through which rust on the flue is visible (Figs. 13.8 and 13.9).

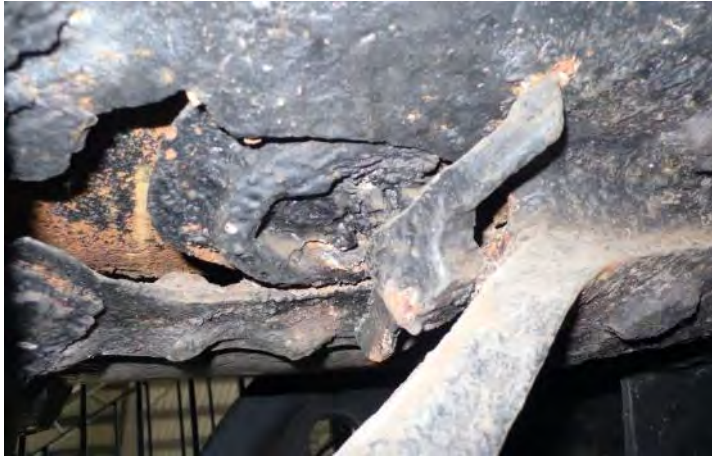
A second mud-hole and closure of similar design is fitted at the trailing end of the boiler, partly covered by the rear drawbar. Corrosion reveals its form in more detail.

Fig. 13.9. Rear mud-hole overshadowed by rear drawbar. Closure rim revealed by corrosion.

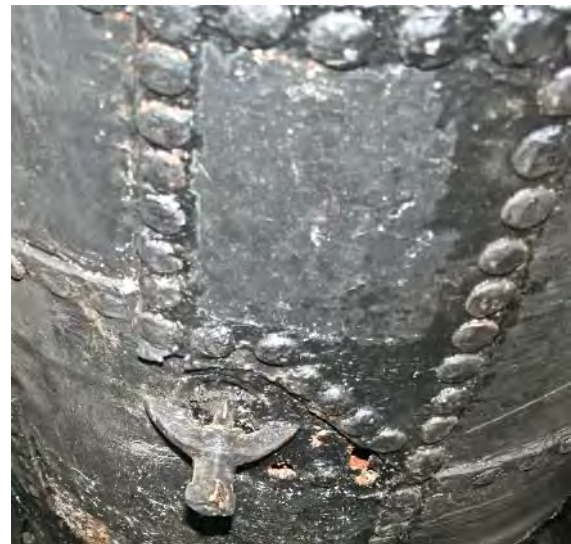
A repair at the bottom of the boiler consists of a plate tailored to avoid the central mud-hole, and rivetted on one side along the boiler plate seam. This patch is 1 ft wide and 2 ft long at its maximum.

Fig. 13.10. Patch repair and holes in region of central mud-hole, looking towards rear of boiler.

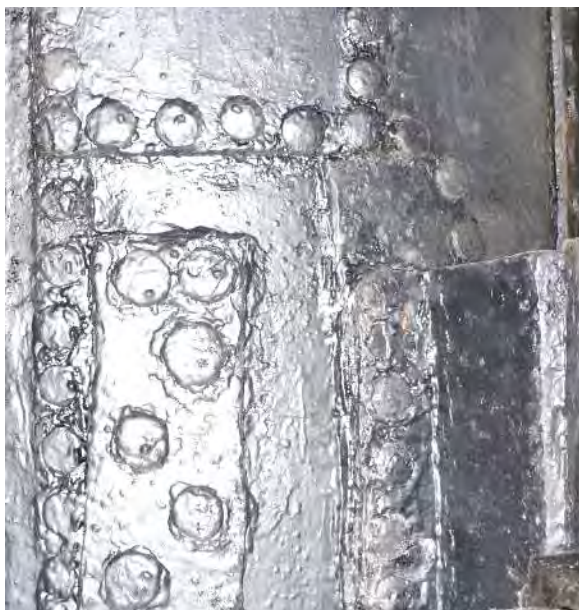
Two further patches are in the areas of the bottom flanges of the right-hand boiler support brackets. The patch at the front bracket is oddly shaped (Figs. 13.2 and 13.11). At its bottom edge it is overlapped by the bottom flange of the bracket and is secured generally by the bracket flange rivets. At its rear corner it underlaps the patch near the central mud-hole, where a single rivet fastens both patches.

Fig. 13.11. Patch under front right boiler support bracket bottom flange (right side of view) extending rearwards to, and, under the corner of the patch near the central mud-hole.

The rivets securing the boiler support brackets carried the weight of the boiler and the reciprocating reaction forces from the cylinders, which would have been generally about half a ton. On Killingworth *Billy* this led to fatigue crack growth around the rivets.³²² The inside of the barrel was inspected for signs of fatigue cracking around the rivets securing the bottom flange of the rear bracket, but none was seen. It is therefore likely that these patches were required because rainwater was trapped in the folds for the flanges and caused corrosion.

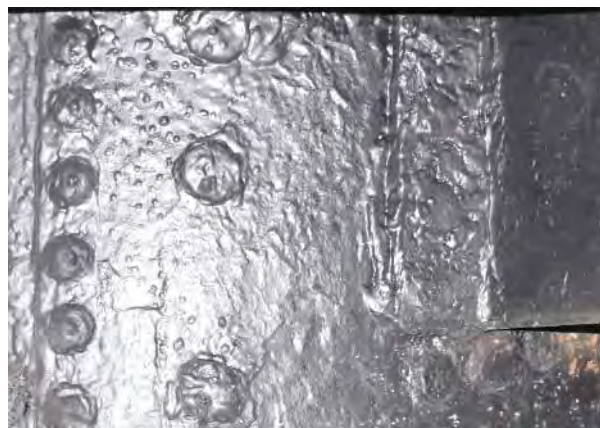
Fig. 13.12. Patch under rear right boiler support bracket bottom flange (right side of view), extending beyond the bracket to both front and rear. Note line of three unused rivets associated with an earlier drawbar.

The patch at the bottom flange of the rear boiler support bracket is rectangular. Its bottom edge is generally secured by the bracket bottom flange rivets, as before. The flange then extends forward of, and rearward of, the bracket flange and also above it (Figs. 13.2 and 13.12).

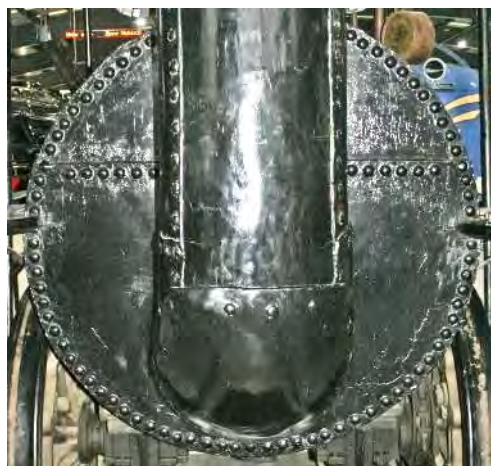
The endplates are made from two pieces of wrought iron plate rivetted together. The bottom piece at the front has an overall height of 35½ in and overlaps the top piece by 3 in, whereas at the rear the bottom piece has an overall height of 36¾ in and overlaps the top piece by 2½ in. The joins are made with $\frac{3}{4}$ in rivets at a nominal 1⅞ in pitch. The endplates are joined to the angle-iron ‘hoops’ at the ends of the boiler barrel with $\frac{3}{4}$ in rivets at the same nominal pitch.

Fig. 14.2. Front endplate.

Fig. 14.3. Rear endplate (Backplate).

Both endplates have 3 in wide flanges formed by swaging the plate. The smooth curve left by the swaging process can be seen to the left of the cover plate (Fig. 14.3). The outside diameter of the flanges so formed is $24\frac{3}{4}$ in, with a nominal bore of 24 in. The flanges provide fixings for the flue projecting from each end of the boiler (Section 15). At the front the centreline of this flange is $16\frac{1}{2}$ in above the bottom of the endplate whereas at the rear this dimension is $17\frac{1}{2}$ in.

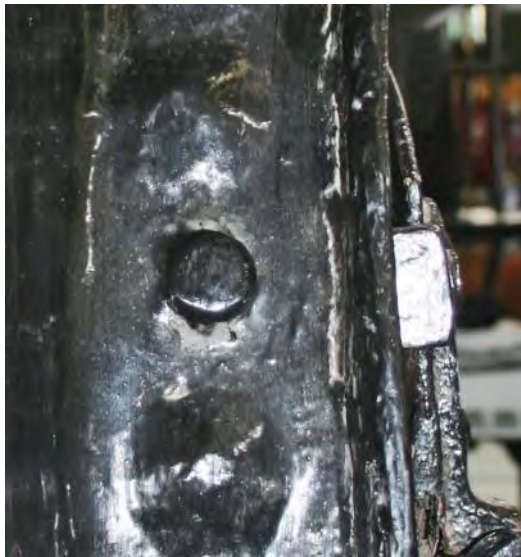
The fire-hole door is hinged to a $\frac{1}{4}$ in thick cover plate which is attached to the circumference of the flue-tube by three short angle-irons, each bolted through the flue and flange in place of a $\frac{3}{4}$ in rivet.

Fig. 14.4. Bolts on angle-iron securing fire-hole plate to backplate flange on the left side.

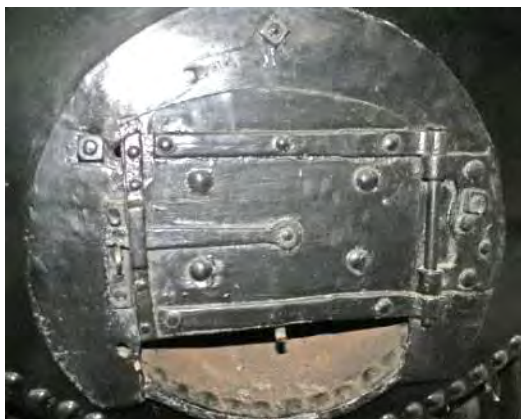
Fig. 14.5. Fire-hole door, hinge-straps, latch and heads of rivets securing baffle-plate.

The round-topped fire-hole door is $\frac{1}{8}$ in thick, 13 in high at its highest and $16\frac{1}{8}$ in wide. It is held by two hinge-straps, each about $1\frac{1}{4}$ in wide and 15 in long with a $\frac{3}{4}$ in diameter hinge-pin, which is in turn fastened to the cover plate by a]- shaped strap. The door carries a conventional latch.

The nuts on the three bolts securing the fire-hole cover plate to the angle-irons are above the fire-door, to the top left of it, and below the top hinge-strap on the right of it (Figs 14.3 & 14.5). The wrought iron cover plate itself is $26\frac{1}{2}$ in diameter, set so that its top edge just overlaps the flange with larger overlaps at its sides and bottom. A round-topped rectangular cut-out gives an opening $14\frac{1}{4}$ in wide and leaves a $5\frac{1}{2}$ in wide annulus at the top. The area of this annulus that would have been exposed to the fire is shielded by a $\frac{1}{2}$ in thick curved wrought iron plate rivetted to it with $\frac{3}{4}$ in spacers.

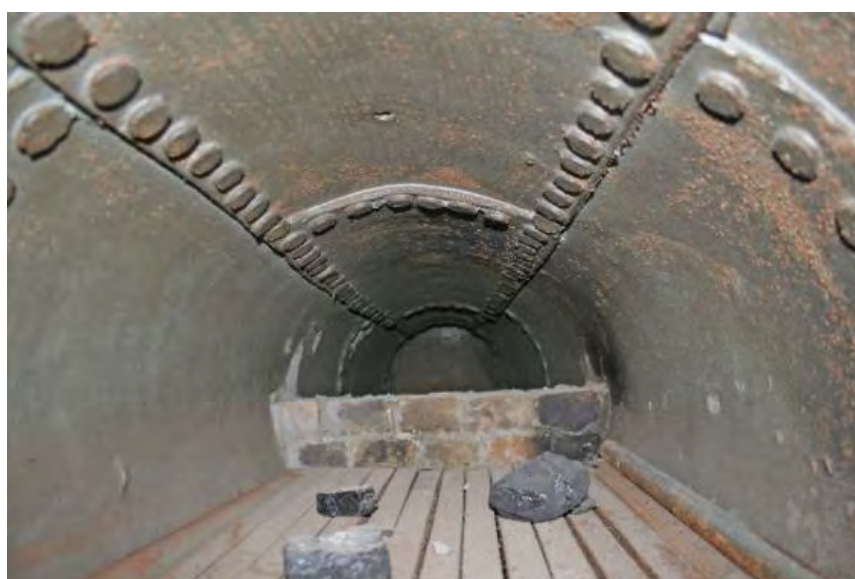
The surviving wrought iron flue has a nominal outer diameter of 24 in. It is an estimated 11 ft long and is constructed of plates $\frac{3}{8}$ in thick, with four plates making up the circumference. These are arranged so that the top and bottom runs of plates are inside the plates at the sides, to which they are joined by $\frac{3}{4}$ in rivets at a nominal 2 in pitch. The top plates are $15\frac{1}{2}$ in wide, the bottom plates $20\frac{1}{2}$ in wide and the side plates both $22\frac{1}{2}$ in wide, all with $2\frac{1}{2}$ in overlaps. There are four plates in each run at top and bottom, of which the longest is around 4 ft 4 in, and three plates in each run at the sides, of which the longest is around 4 ft 11 in., all with 2 in to $2\frac{1}{2}$ in overlaps. These longer plates are all towards the front end of the flue, implying that the rear plates had been cut so that sections of them could be replaced. The area of the flue directly above the fire with the original component would have been liable to damage from the high surface temperature since most of the heat transfer to the water in the boiler occurred there (Section 27). These flue plates may also have been subjected to chemical attack from the products of coal combustion.

Fig. 15.1. Inside of flue, with fire-grate and brick wall.

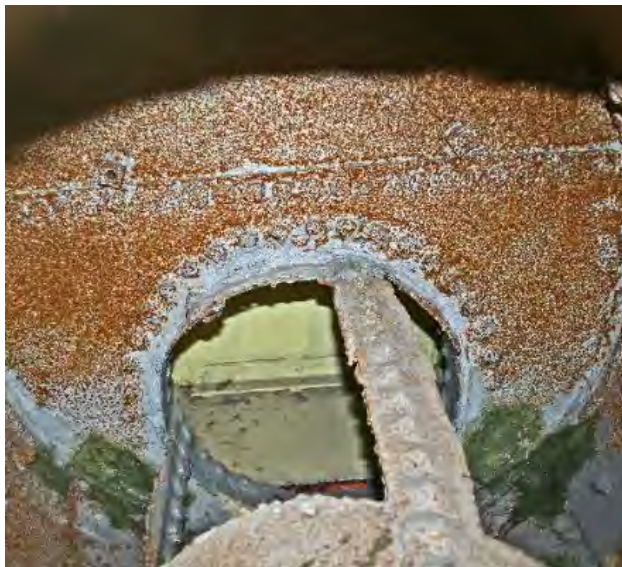
An unexpected feature of the flue is the absence of corrosion damage. Rainwater would have entered the chimney and thence the flue during the many years when *LOCOMOTION* was on display in the open air (Section 8). The condition of the flue in *INVICTA* shows the damage that can occur in such circumstances.³³⁵

Fig. 15.2. Corrosion damage due to rainwater ingress on *INVICTA*'s flue.

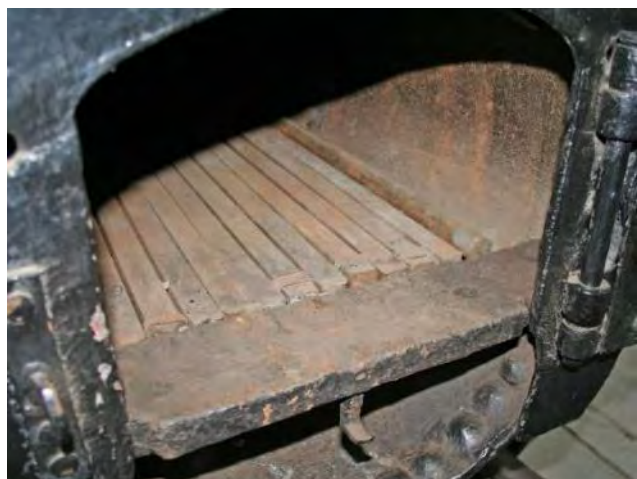
Thirteen wrought iron fire-bars (an excessive number), 4 ft long and $1\frac{1}{4}$ in square in section, are supported by transverse cast iron joists, 3 in square in section. These joists are moveable but are placed 11 in and 3 ft 2 in from the back ends of the fire-bars. The ends of these joists are crudely shaped but are supported by the edges of the bottom flue plates. There is an air gap of only 3 in between the bottoms of the joists and the bottom of the flue.

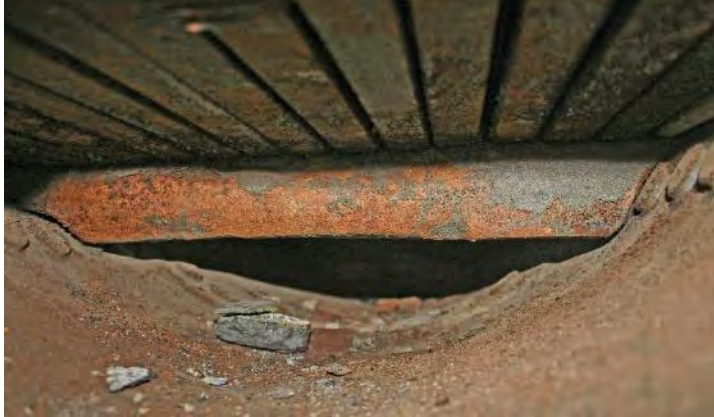
Fig. 15.4. Joist supporting fire-bars.

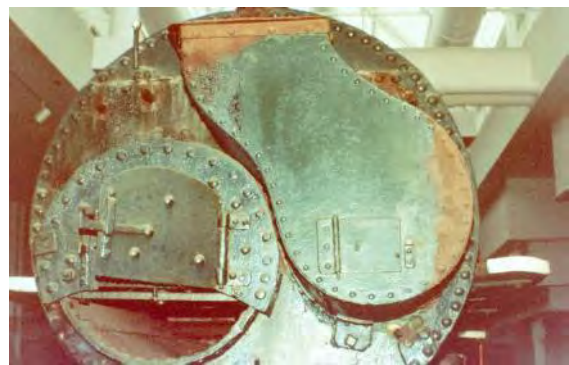
Fig. 16.4 *SAMSON*'s front end with smokebox housing removed to show the return flue exterior diversion, and the fire-grate. [Michael R. Bailey]

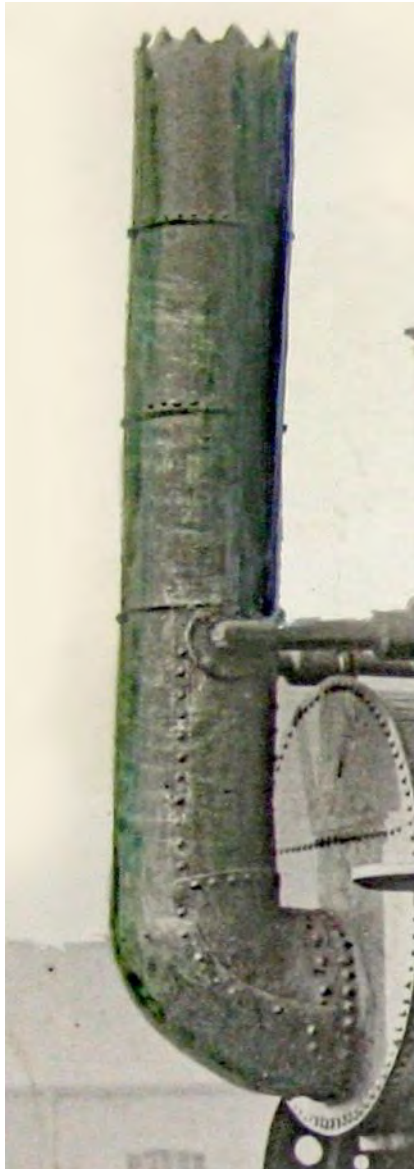
Fig. 16.5 1857 view of the chimney as first installed on to *LOCOMOTION* on the plinth at Darlington North Road Station [NRM, York HQ Photos, Box 9, 1065 & x35789]

In spite of this, it is noteworthy that the transition curve upper plate has been replaced at some stage, the surviving plate being slightly larger than the previous plate, through photographic comparison (Figs. 16.8 & 16.9). It is also likely that the upper chimney plates have been replicated at some stage, the surviving fluting being better defined than the 1857 example (Figs. 16.5 & 16.6).

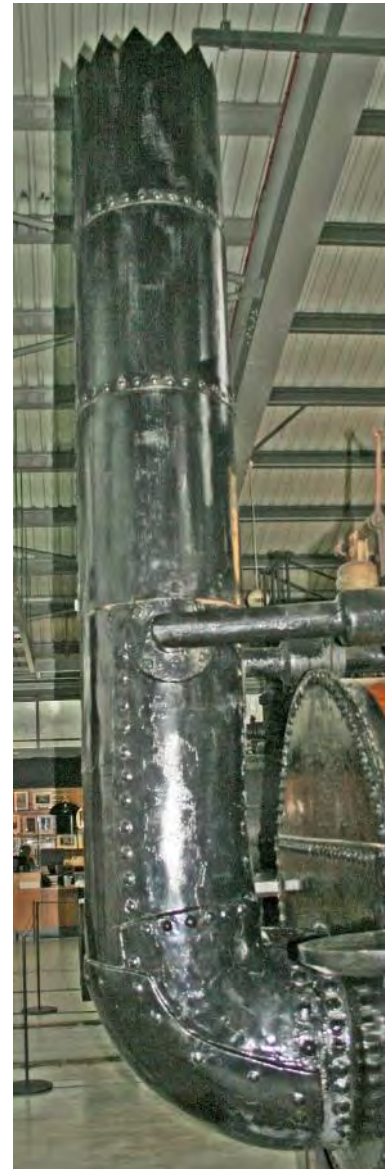
The chimney is 10 ft 3 in tall, and its top is 13 ft 1 in above rail level. The external diameter of the lower chimney is 18½ in. As the plates are ¼ in thick, the internal diameter is 18 in, 2 in more than it had been when last in service, and 7 in less than it had been when first built in 1825. The upper chimney (5 ft 7½ in high) is formed of three rings, each riveted to the outside of the ring beneath it. The lower ring slides over the lower chimney by 3 in. The external diameter of the uppermost ring is thus 20 in. It is retained in place by four bolts. The centre-line of the exhaust pipe flanges is 7 ft 1½ in above rail level.

Fig. 16.6 2022 view of the chimney

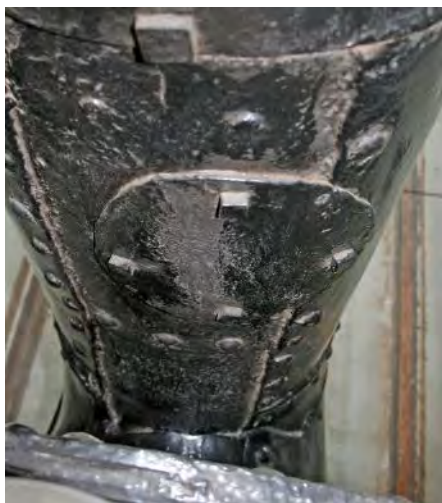
The lower chimney is formed of small pieces of previously used wrought iron plates, forged into shape and riveted together, rather than being formed from new in a pre-determined layout. Some plates are $\frac{3}{16}$ in thick, and appear to have been part of a previous chimney, whilst others are $\frac{1}{4}$ in thick.

Fig. 16.7 Downward view of the rear vertical plate of lower chimney which has a circular patch covering a previous opening, possibly for an exhaust pipe flange.

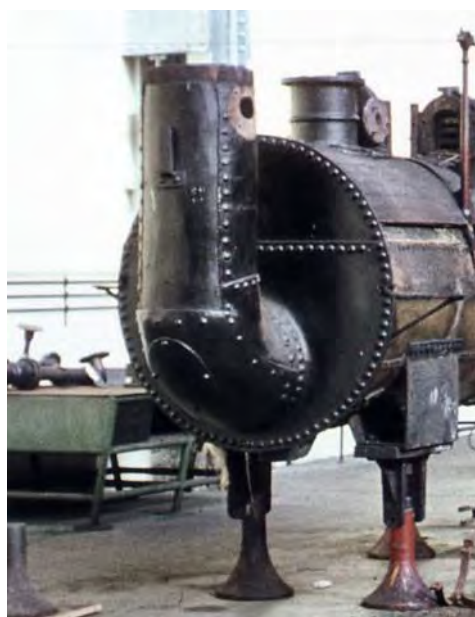
In 1924 a bracket was riveted on to the front vertical plate in readiness for the centenary parade in the following year when it was used to carry the number '54' on a circular disc. The bracket remained in place through to 1961. It survived the initial restoration (Fig. 16.10), but a last minute change of mind belatedly saw it removed. Both the hole on the lower cover plate and the holes left from the leading bracket fixture were filled with an unknown substance and sanded smooth before repainting at Darlington North Road.

Fig. 16.8 Front view of lower chimney taken before restoration in 1961. [J.W. Armstrong Trust – 015]

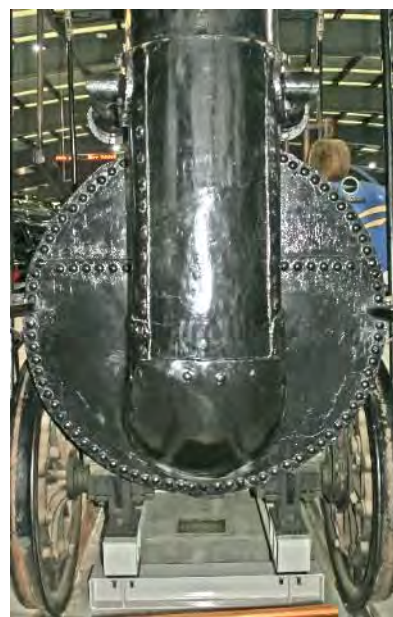
Fig. 16.9 Front view taken during the recent survey.

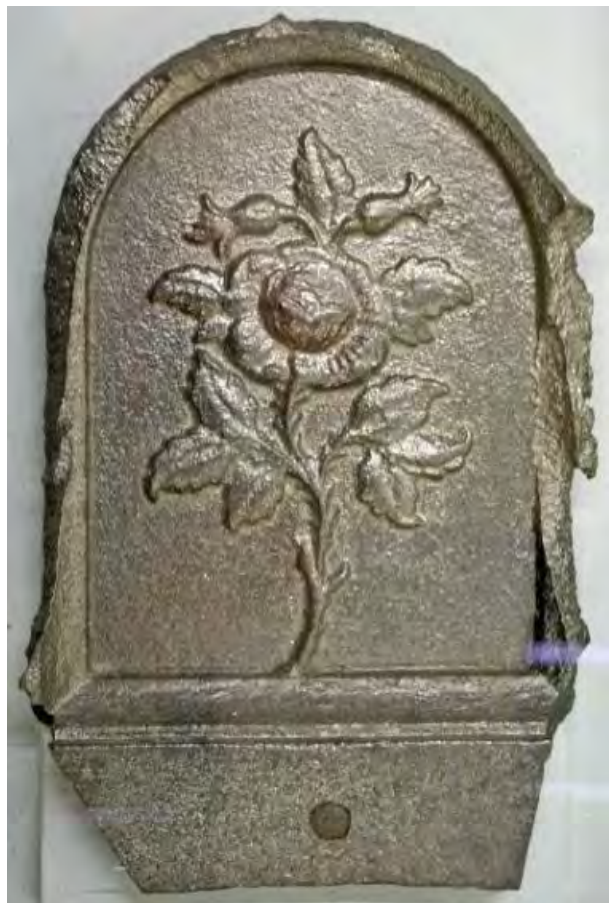
The National Collection includes a decorated valve-chest cover that is stated to be one of *LOCOMOTION*'s original valve-chest covers that was replaced prior to the 1875 Jubilee.³⁵⁷ The cover has been cast with a flower symbol, but its representation has not been identified. The cover has broken edges, but measurements indicate that it would have been of the right size to fit the surviving valve-chests, and possibly those on *Active*.

Fig. 17.5. Decorated valve-chest cover.

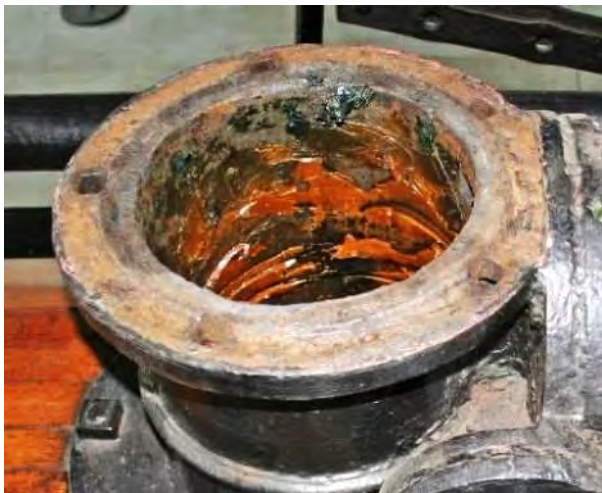
At the top, each cylinder has a 1 in thick flange with an external diameter of $15\frac{1}{4}$ in, with a $\frac{1}{4}$ in high and $\frac{7}{8}$ in wide circular upstand above this, for sealing the cylinder bore to the top cover. The cylinders have vertical humped protrusions running from top to bottom to contain the steam passages. These passages are 4 in by $\frac{7}{8}$ in section and enter the cylinders at top and bottom. The top of the bottom entry is $31\frac{1}{2}$ in below the top of the upstand and the top opening is $1\frac{1}{4}$ in below this level.

Fig. 17.6. Front cylinder top flange with upstand.

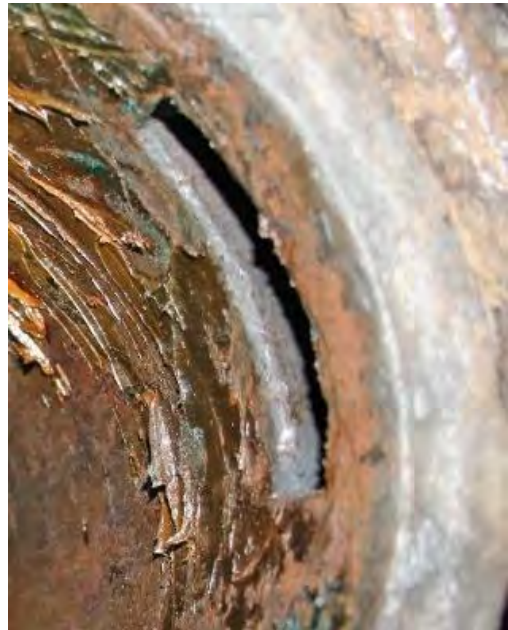
Fig. 17.7. Front cylinder top steam passage.

These passages curve round to enter the port-face via steam ports 4 in wide and $\frac{7}{8}$ in high, these ports being separated by $3\frac{1}{4}$ in. The port-face itself is $7\frac{1}{4}$ in high and 6 in wide. Midway between the steam ports is a further 1 in high port leading to the exhaust routes. These exhaust routes curve round both sides of the cylinder bore to exit via $3\frac{1}{2}$ in diameter stub pipes terminating in $8\frac{1}{2}$ in diameter flanges either side of the cylinder casting, for connection to the exhaust pipes (Section 21). Each port-face is surrounded by a shallow recess which in turn is partially surrounded by a flange. This flange rises from the boiler attachment flange (see below) on each side of the recess to an arch at the top. The flange is $\frac{3}{4}$ in thick and $3\frac{1}{2}$ in wide, with a width across the flanges of $13\frac{1}{2}$ in. The top of this arch is $1\frac{1}{4}$ in above the cylinder top flange and its back face is only 7 in from the cylinder centreline, requiring the top cover to be cut along a chord (see below).

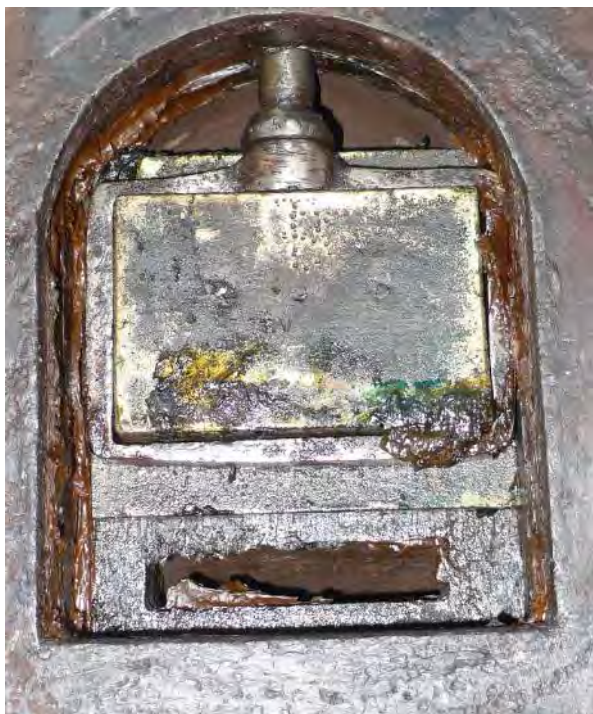
Fig. 17.9 Front cylinder left side exhaust flange and flange for bolting to boiler.

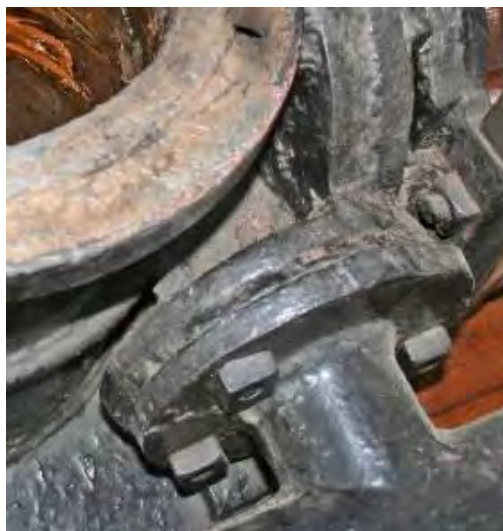
This flange is bolted along its sides and top to an identical flange on the separate valve-chest casting, which also has a boiler attachment flange. The locations of these six $\frac{3}{4}$ in bolts are constrained by the valve-rod gland housing (see below) and the two stub exhaust pipes, only leaving space for a bolt either side of the former and above and below the latter. There are no bolts joining these two castings at the bottom, where their boiler attachment flanges butt together. This was a feature of the 'standard' Killingworth-type design and appears in the other remaining early locomotive of this type, Killingworth *Billy*.³⁵⁸

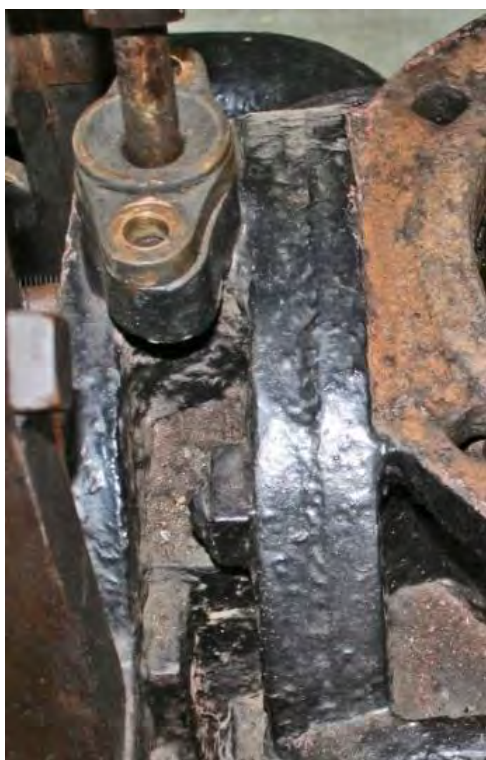
Fig. 17.10 Valve-chest attachment flanges on rear cylinder.

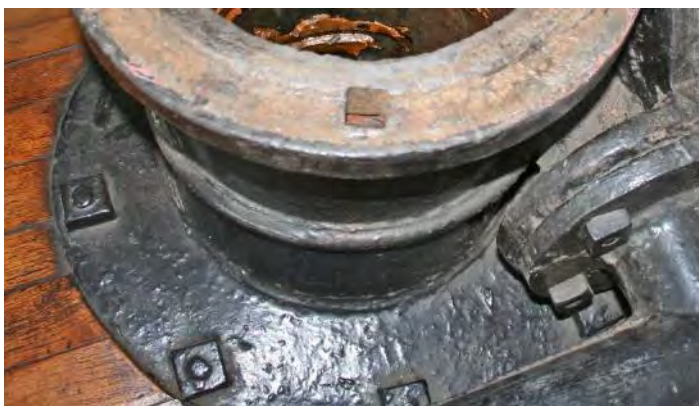
Fig. 17.11 Front cylinder bolting-down flange.

The cylinders are bolted to the boiler via flanges, each using seven $\frac{3}{4}$ in bolts at a $6\frac{5}{8}$ in pitch. These flanges are generally rounded at a $10\frac{1}{2}$ in radius and $18\frac{1}{2}$ in long in plan view (Fig. 13.2). The bottoms of the flanges are curved to suit the boiler shell and the flanges themselves are 1 in thick at their edges increasing to $1\frac{1}{2}$ in at the cylinder barrels. The flange bolting faces at the boiler crown are $13\frac{1}{4}$ in below the tops of the cylinder castings.

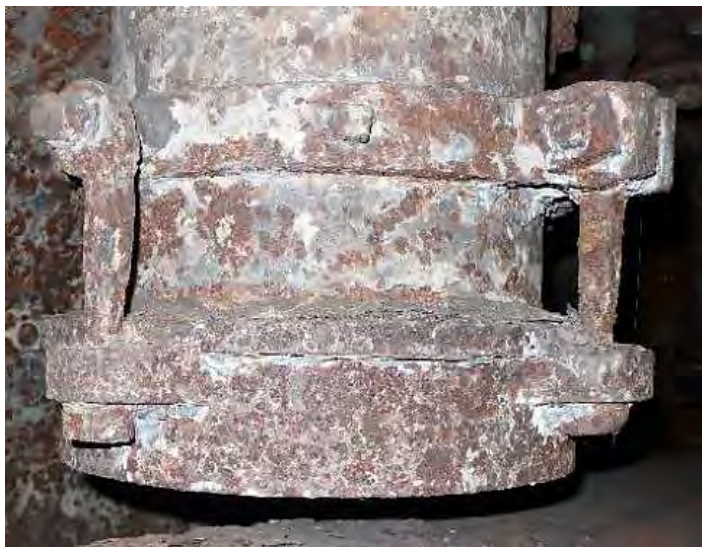
At some time after 1828 the rear cylinder suffered a major accident, which resulted in the bottom (internal) cylinder flange being broken. It is likely that this was the result of a failure in the drive to the rear axle, perhaps a crank-pin failure, in which event the steam pressure would have accelerated the piston and crosshead to impact the flange forcefully. The cylinder was repaired (Figs. 17.4 and 17.12).

Fig. 17.12. In-service repair to bottom of rear cylinder.

The obvious strength of the four tie-bars from the clamping ring to the replacement cylinder bottom cover indicates that the repair relied on more than friction to hold the clamping ring in place and the salt deposits on the surfaces indicate that the locomotive remained in-service for a considerable period afterwards. It is therefore suggested that the clamping ring has internal studs located in shallow holes in the cylinder wall, in which case the repair could have withstood the operating steam pressure.

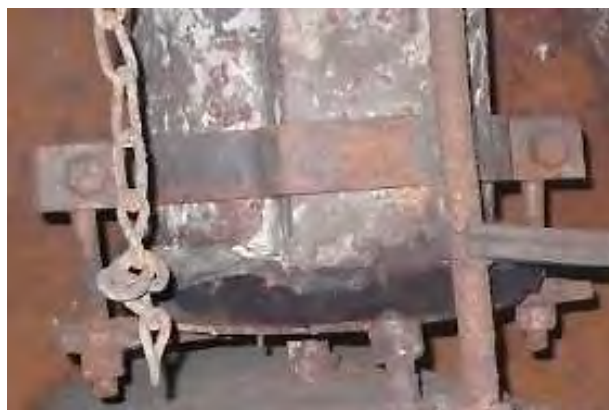
This repair contrasts with a similar one on the front cylinder. Here the two tie-bars are slimmer and there are no salt deposits on the clamping ring, etc., indicating that the repair was made after *LOCOMOTION* was taken out of service. It is possible that, in preparation for steaming the locomotive during the 1875 'Jubilee' celebrations, it was found that the cylinder bottom flange was damaged and had to be removed. The repair, which provides a bar to hold a new spigotted bottom cover in place, was made on the basis that it only had to carry the very low pressure necessary to rotate the raised wheels.

Fig. 17.13. Post-service repair to bottom of front cylinder.

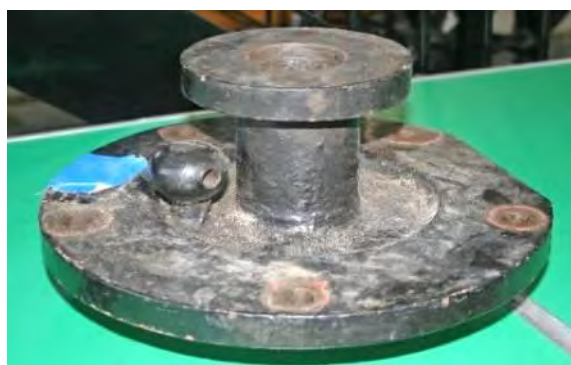
The cylinder top covers are dissimilar but still interchangeable. Both are of $15\frac{1}{4}$ in diameter with a straight cut along a chord $14\frac{1}{2}$ in from the opposite side of the cover, thus removing a $\frac{3}{4}$ in wide piece. Each cover has five holes at $7\frac{3}{4}$ in centres for $\frac{3}{4}$ in bolts. The flange thicknesses are $\frac{7}{8}$ in (front) and 1 in (rear), with spigot diameters of $10\frac{1}{8}$ in (front) and $9\frac{3}{4}$ in (rear) and spigot depths of only $\frac{5}{8}$ in (front) and 1 in (rear). Each cover spigot has a hole, normally closed by a screw, for the introduction of lubricant. The heads of the screws (again of different patterns) are made for turning with tommy bars. The stuffing boxes are also dissimilar, the front one having a 3 in bore and the rear a $3\frac{3}{8}$ in bore. There would normally be a $1\frac{5}{8}$ in diameter hole for the piston rod below these bores, but these holes have been bored out so that bronze bushes could be fitted that fill the stuffing boxes and run through to protrude some $\frac{7}{8}$ in into the top of the cylinder bore. It is very likely that these bronze bushes were fitted in preparation for the 1925 Centenary parade, when *LOCOMOTION* was propelled by a petrol engine in the tender.

Fig. 17.14. Front cylinder top cover.

Externally, the front stuffing box rises $3\frac{3}{4}$ in at $3\frac{5}{8}$ in diameter and then increases to $6\frac{5}{8}$ in diameter to provide a circular flange $\frac{7}{8}$ in thick. This flange has two $\frac{3}{4}$ in diameter holes at $4\frac{7}{8}$ in centres for securing the gland. The rear stuffing box rises $3\frac{1}{2}$ in above the flange at 5 in diameter and then increases to form a flange $5\frac{1}{4}$ in diameter and $1\frac{3}{8}$ in thick, with two lugs with a $\frac{3}{4}$ in diameter hole in each, the holes being at $6\frac{1}{4}$ in centres, for tightening the gland. The glands themselves have flanges to match those on the stuffing boxes and have been bored for further bronze bushes. Fig. 17.4 shows the rear top cover before these late alterations were made.

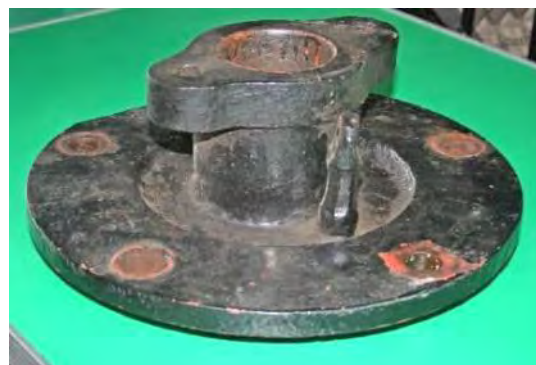
Fig. 17.15. Rear cylinder top cover.

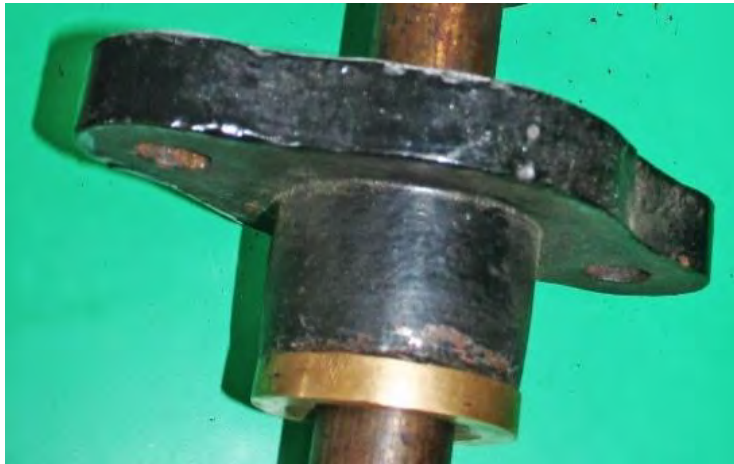
Fig. 17.16. Rear cylinder bushed gland with bronze bush

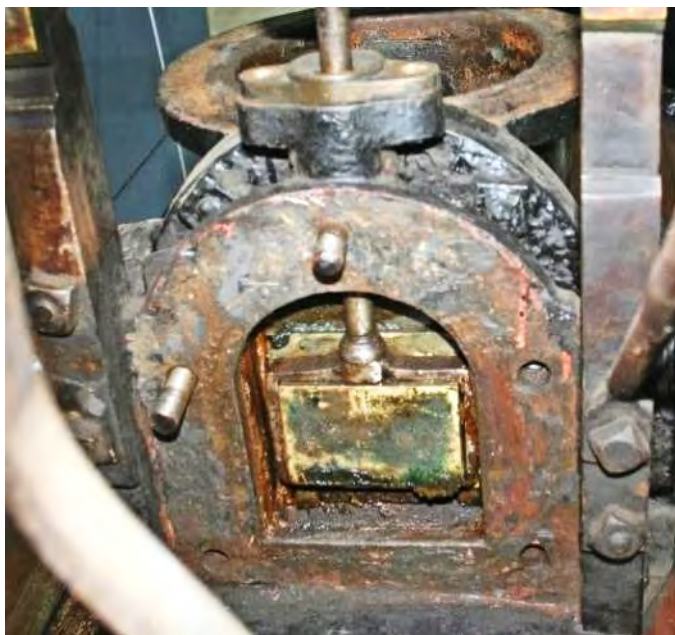
The two valve-chests are identical with an overall length of $3\frac{3}{4}$ in. They are attached to the cylinder castings via flanges $\frac{3}{4}$ in thick, as described above. At the opposite ends they have smaller flanges for the attachment of the covers. This includes flanges running across the tops of the boiler attachment flanges. The tops of these flanges are 1 in below the flanges for the cylinder and the flanges themselves enclose a space 8 in high to the top of the arch, and $6\frac{1}{4}$ in wide. These flanges are generally $2\frac{5}{8}$ in wide and are $\frac{3}{4}$ in thick. Five $\frac{3}{4}$ in diameter studs are screwed into each of these flanges for the attachment of the covers.

Fig. 17.17. Rear valve-chest, including side protrusions for the attachment of columns.

Either side of these flanges are vertical protrusions of $1\frac{5}{8}$ in square section in plan view. These protrusions are $11\frac{3}{4}$ in apart and originally extended above the valve-chests as short square columns, to which wrought iron columns are bolted to support valve-gear components (Section 20). Three of the four such extensions have broken off at their tops, leaving them some $2\frac{3}{4}$ in short. The undamaged extension is on the right-hand side of the rear valve-chest.

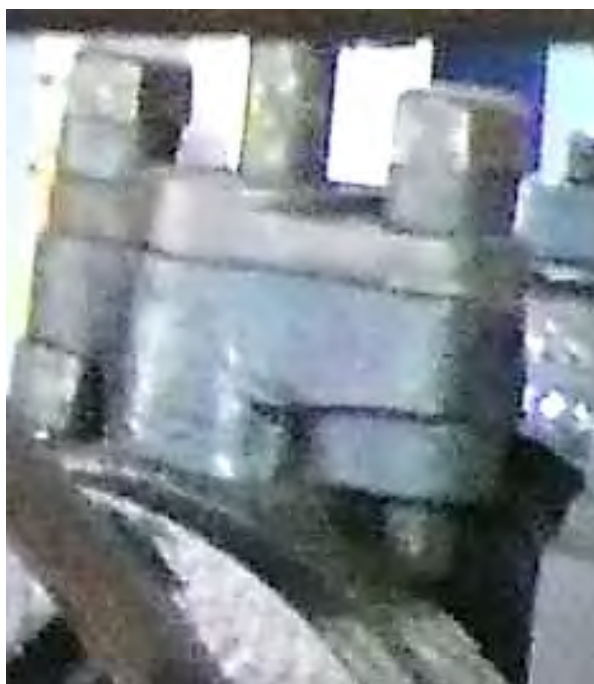
Fig. 17.18. Rear valve-chest stuffing box.

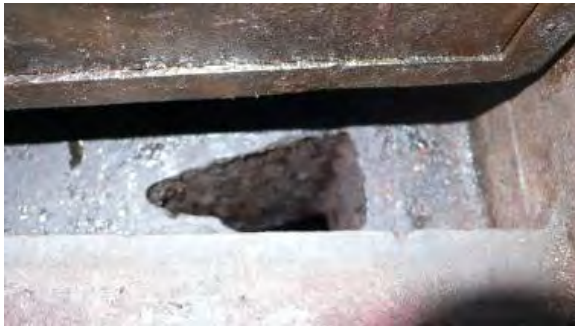
Each valve-chest extends downwards to provide a steam passage, probably fan-shaped in section, from the regulator system in the boiler (Section 22) and through the boiler attachment flange into the valve-chest. The passage terminates about an inch below the boiler crown. The exact arrangement of this function is not clear, being obscured by later modifications (Section 18), which include the insertion of a plate into the bottom of each valve-chest, but it is likely that the passages are similar to those on Killingworth *Billy*.

Fig. 17.19. Steam passage from boiler to bottom of valve-chest on Killingworth *Billy*.

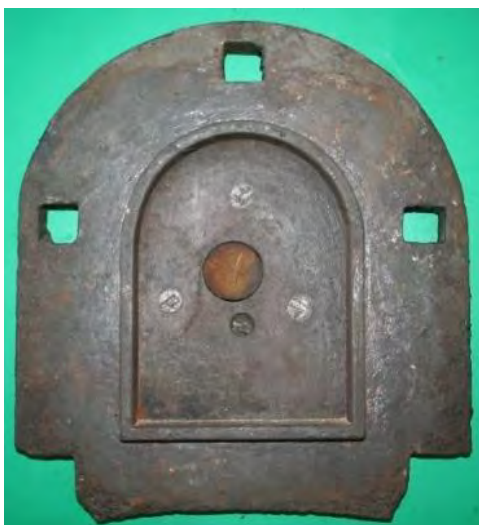
The cast iron valve-chest covers are identical except that the cover on the front chest has a ridge for locating it in the valve-chest opening and is broken at the bolt holes in the bottom corners. A narrow plate, with bolt holes at each end and placed across the bottom of the cover, is used to retain it. These covers are profiled to match the adjacent flanges on the valve-chests and are curved at the bottom to match the boiler attachment flange curvature. They are $11\frac{1}{2}$ in wide and $\frac{3}{4}$ in thick. The covers have central holes $1\frac{5}{8}$ in diameter surrounded by three $\frac{5}{8}$ in diameter tapped holes for the attachment of the steam supply pipework for the 1875 'Jubilee' celebrations. All these holes are now plugged. With the use of the gasket compound, the only machining required on the valve-chest castings was the drilling of the holes for the valve rods and the boring out of the stuffing boxes.

Fig. 17.20. Front valve-chest cover, showing locating ridge, broken bottom corners and plugged holes.

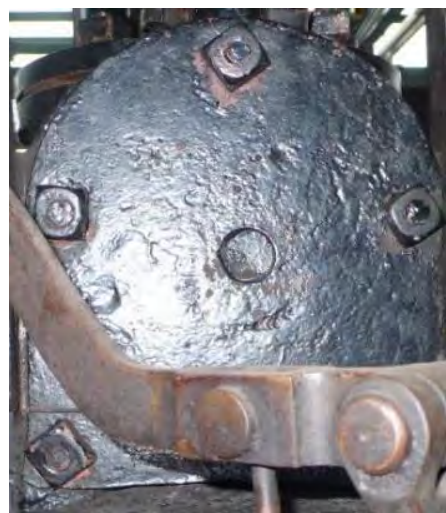
Fig. 17.21. Back of front valve-chest cover, showing retaining plate in bottom left corner.

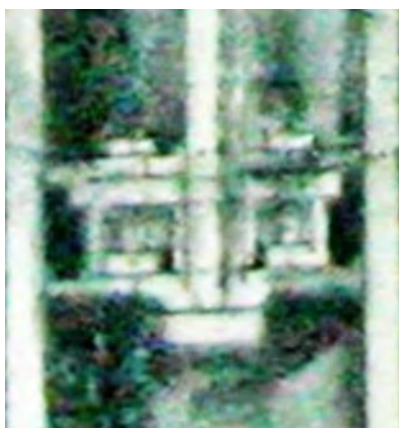
The pistons are missing, the piston rods having been sawn through, probably before the 1925 Centenary parade. A guide on their appearance is provided by an illustration in the 1924 British Empire Exhibition booklet.³⁶⁷ Although not clear, it appears to show a central section, fixed to the piston rod with a broad cotter, and possibly containing springs for pressing the rings (not shown) against the cylinder bore, with a bottom plate held in place by a large nut, and a removable top plate, possibly for access to adjust the springs.

Fig. 18.5. Extract from the British Empire Exhibition booklet. [LNER, 1924, pp.12/13]

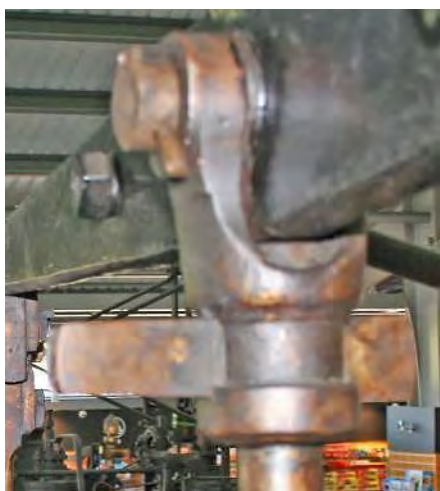
The wrought iron piston rods are $1\frac{5}{8}$ in diameter, however their original lengths are not known. The top of each rod is secured in a cast iron clevis by a split cotter. Where the piston rod enters it, the clevis is $4\frac{1}{8}$ in diameter, but it is necked down to 3 in diameter for $1\frac{1}{2}$ in where the cotter fits. This split cotter is $7\frac{1}{2}$ in long, $\frac{3}{8}$ in thick and $1\frac{7}{8}$ in wide at its head. The clevis is $6\frac{1}{2}$ in long from the bottom to the centreline of the gudgeon pin, which is $1\frac{3}{4}$ in diameter with a $2\frac{1}{2}$ in diameter head. The gudgeon pin is retained by a split pin.

Fig. 18.6. Clevis on front piston rod.

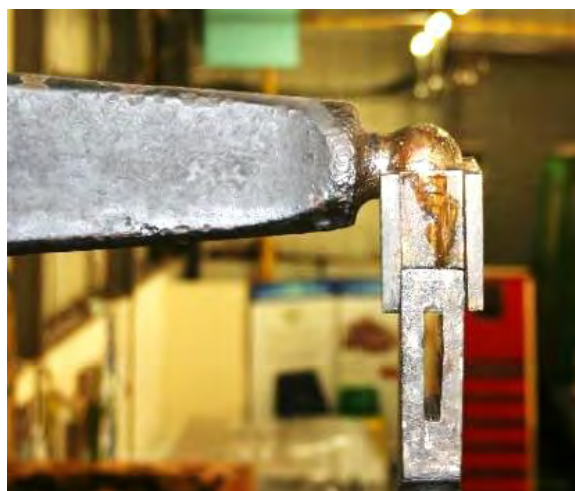
Fig. 18.7. Spherical joint at end of crosshead on Killingworth *Billy*, very similar to those on *LOCOMOTION*.

The gudgeon pin passes through a hole in the crosshead which has raised bosses on both sides to give an overall thickness locally of 2 in. Elsewhere the crossheads are 1¼ in thick and 5 in high at their clevises tapering down to 2 in high and then widening to 2 in diameter near their ends. The ends of the crossheads are formed into 2 in diameter spheres to work within the connecting rod top bearings, similar to those employed on Killingworth *Billy*. The centres of these spherical ends are 67½ in apart across the locomotive. The necks at these spherical ends are only 1¼ in diameter to carry half the piston load. It is likely that fatigue failure at a neck occurred occasionally and caused significant damage to the related cylinder (Section 17).

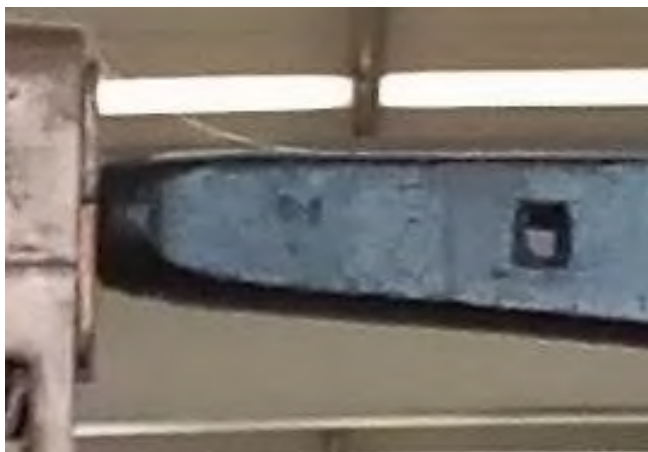
The rear crosshead has a ½ in square hole located on the right-hand side, 27¾ in from the piston rod centreline. It is very likely that this enabled the connection of a rod to drive a feed-pump set vertically at the side of the boiler (Section 23). At the time that this hole was used the associated boiler must have been no larger than 4 ft in diameter, otherwise the pump-rod would not have fitted past the side of the boiler.

Fig. 18.8. Square hole in right side of rear crosshead.

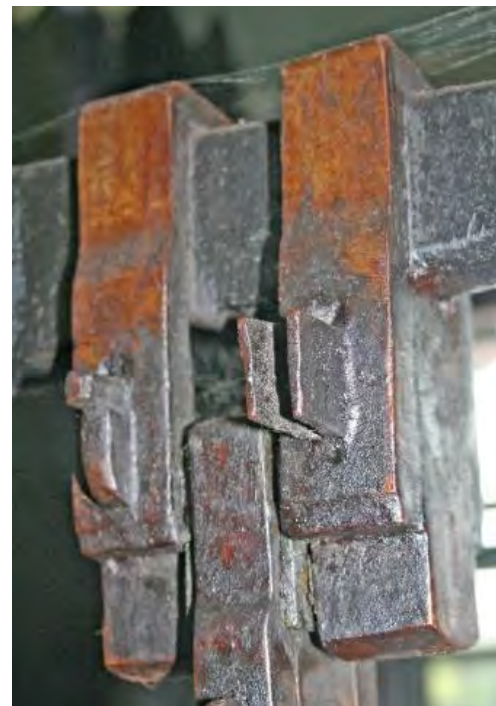
Fixtures are clamped to the right side of the front crosshead for the top bearings of a rod connected to the lever that operates the feed-pump (Section 23).

Fig. 18.9. Drive to feed-pump clamped to front crosshead right side.

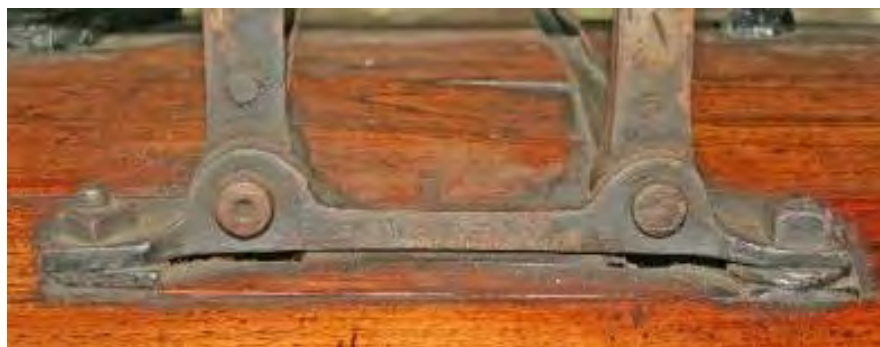
Each pair of swinging links is cross-braced with 1 in by $\frac{1}{4}$ in bars forged together at their mid-points. Fig. 18.11 shows that the front cross-bracing is distorted towards the right-hand side in this view.

Fig. 18.10. Swinging link bearing frame bolted to boiler, with pivots for both front and rear linkages.

Fig. 18.11. Rear right swinging link on very left of view, with cross-braces for both sets of swinging links meeting at forged joints at lower centre, looking towards the rear.

These radius rod cross-shafts are carried in bearings inboard of the radius rods, the bearings being supported by wrought iron columns bolted to extensions of the valve-chests (Sections 17 and 20). These columns are interconnected fore and aft by $\frac{3}{4}$ in diameter diagonal bracing rods (visible at the sides of Fig. 18.11), forged together where they cross.

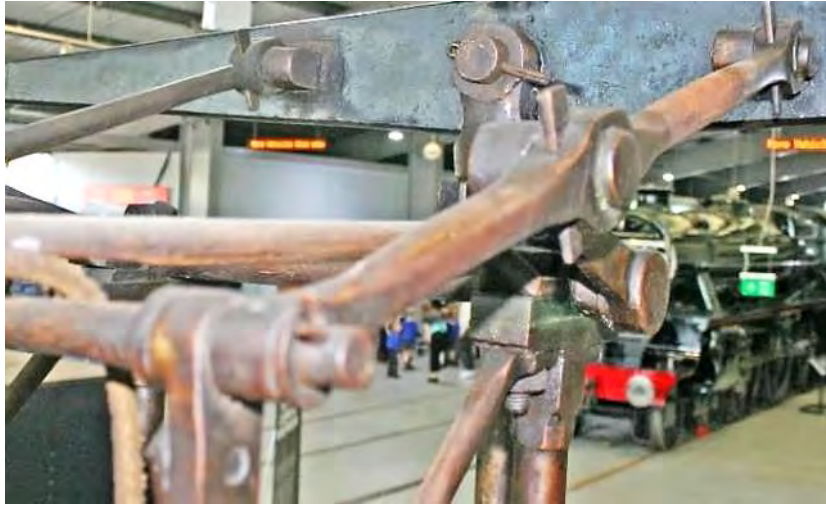
At their tops, each pair of swinging links is joined by another $\frac{7}{8}$ in diameter cross-shaft, which extends either side to provide pivots for the ends of the pair of half-beams. These half-beams extend from these pivots to pivot pins attached to the crossheads and carry adjustable bronze bearings for the ends of the radius rods.

Fig. 18.12. Pivots for rear left half-beam; that for the top end of its swinging link in left foreground and that for its connection to the crosshead in right background.

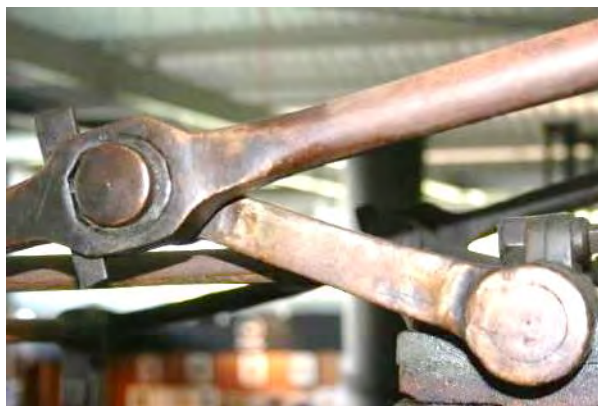
At their other ends the radius rod bosses, at $2\frac{1}{4}$ in diameter and $1\frac{3}{8}$ in wide, are keyed to the ends of $1\frac{1}{2}$ in diameter cross-shafts, $19\frac{1}{4}$ in long. These keys are $\frac{3}{4}$ in wide on the rear radius rods but only $\frac{1}{2}$ in wide on the front radius rods. These keys would have resisted relative rotation of the radius rods, necessary to allow the crosshead to tilt to follow vertical movements of the wheels on an uneven track.

Fig. 18.13. Bearing on rear left half-beam for radius rod, and radius rod itself.
