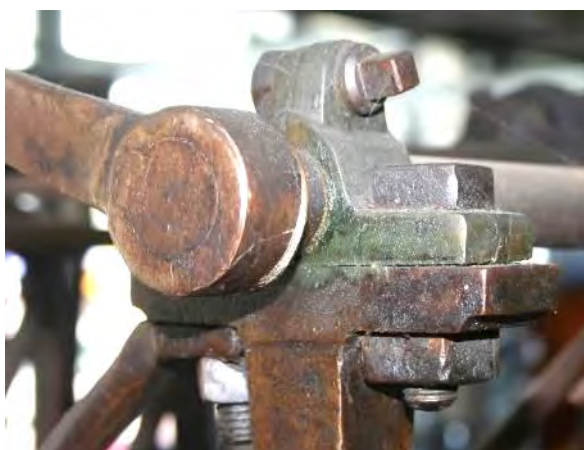
These radius rod cross-shafts are carried in bearings inboard of the radius rods, the bearings being supported by wrought iron columns bolted to extensions of the valve-chests (Sections 17 and 20). These columns are interconnected fore and aft by $\frac{3}{4}$ in diameter diagonal bracing rods (visible at the sides of Fig. 18.11), forged together where they cross.

Fig. 18.14. Bearing for left rear radius rod.

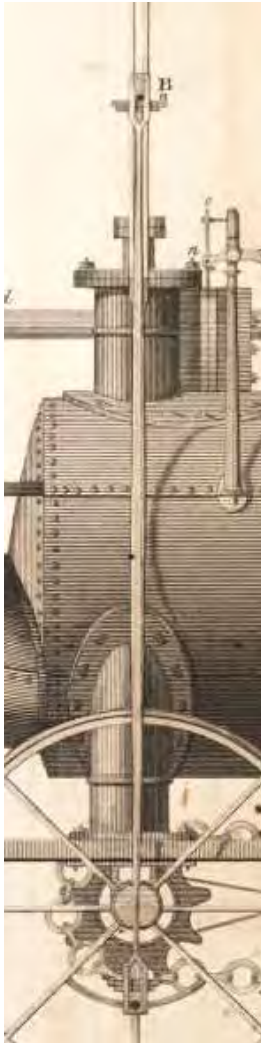
Connecting rods on early Killingworth locomotives were about 9 ft 6 in long between centres, about 1 in diameter (or less) at their ends, swelling to about 2 in diameter at their mid-lengths (scaled from Fig. 19.1).³⁶⁸

Fig. 19.1. Front connecting rod on early Killingworth locomotive. [Wood, 1825, Plate V – detail.]

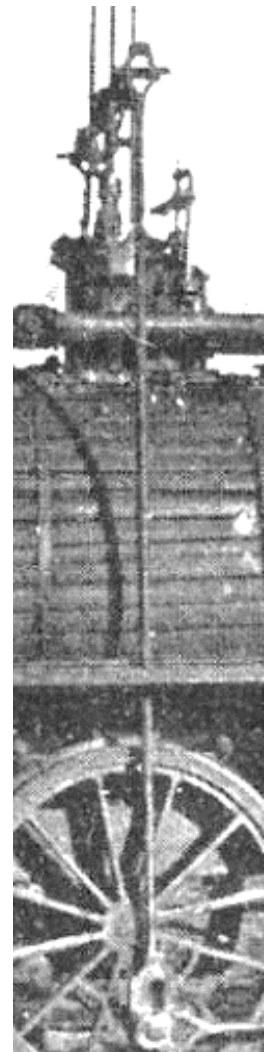
The rod ends were forged into closed ‘eyes’ to contain the bearing brasses, which were retained by double cotters. A similar design survived on the Mount Moor Colliery locomotive until at least 1862, except that ‘eyes’ were of a curious elongated shape, again with the brasses at the extremity of the ‘eyes’. The 1821 Killingworth locomotive is also shown with this type of bearing ‘eye’³⁶⁹. It is therefore very likely that *Active* was originally fitted with connecting rods of one of these designs, but shorter since *Active*’s boiler was mounted lower.

Fig. 19.2. Front connecting rod on Mount Moor Colliery locomotive. [Fig. 1.4 – detail.]

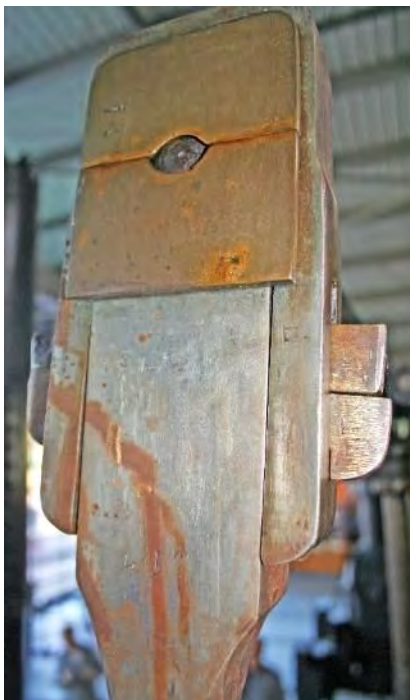
The wrought iron connecting rods are 8 ft 1 in long between the bearing centres. The top bearings contain 2 in diameter spherical recesses for the ball ends of the crossheads. Externally these split bearing brasses are 3 in wide, 3½ in high and 2 in thick. Their fixing straps are formed from wrought iron bar ½ in thick and 1½ in wide, with square corners at their tops, and are secured to the connecting rods by the traditional gibs and cotters.

Fig. 19.5. Top bearing on front left connecting rod.

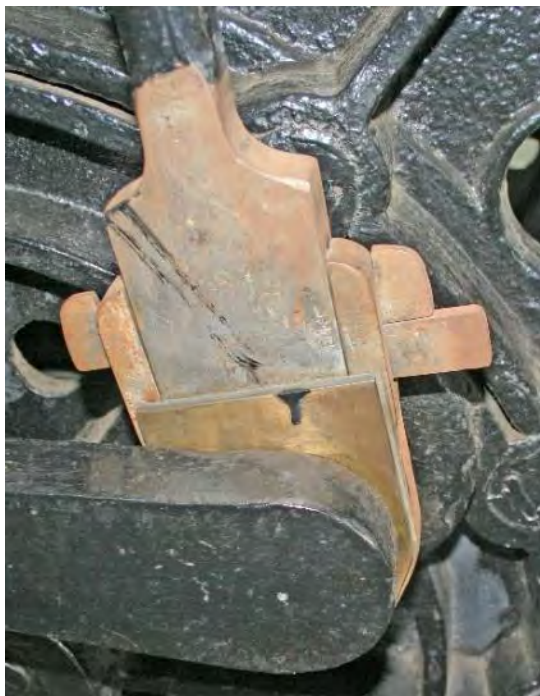
The bottom bearing brasses had to be wider than those at the top to encompass the crankpins. The bottom ends of the connecting rods are 3 in wide and 1 in thick, with split bearings, externally 4 in wide by $4\frac{7}{8}$ in high and $1\frac{3}{4}$ in thick. These are parallel bearings rather than spherical, as fitted at the tops of the rods. They are held in place by straps formed from 1 in by $\frac{5}{8}$ in bar and are rounded around the brasses at the bottom. The straps are secured to the connecting rods by gibs and cotters. The bottoms of the connecting rods are also stamped. The front left rod bears LFB, which also appears on the strap, gib and cotter and the similar components on the other wheels are stamped in line with this.

Fig. 19.6. Bottom bearing on front right connecting rod.

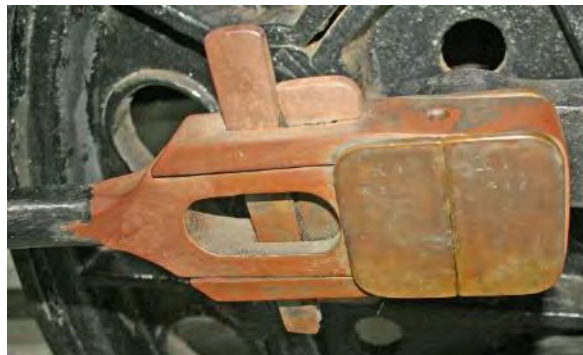
Fig. 19.7. Front end of right coupling rod.

The coupling rods are 5 ft $1\frac{7}{8}$ in long between centres. They are of wrought iron and are also $1\frac{3}{8}$ in diameter near their ends and $1\frac{3}{4}$ in diameter at their mid-lengths. The coupling rod ends are of a different design to those on the connecting rods, being hollowed out. These ends are $2\frac{1}{4}$ in wide and 1 in thick, with square-cornered straps formed from 1 in by $\frac{1}{2}$ in bar. The straps are secured to the rod ends by gibs and cotters, although unusually the gibs are positioned between the cotters and the brasses rather than close to the ends of the straps. The split brasses themselves are externally 2 in thick, $3\frac{1}{4}$ in wide and $3\frac{7}{8}$ in long. Internally they have been machined to provide 2 in diameter spherical recesses. The front end of the left-hand rod and its brasses have been stamped L1. The front end of the right-hand rod is not stamped, but the brasses are stamped both R1 and R1F. At the right rear the brasses are stamped R2, but the rod seems to be stamped R1.

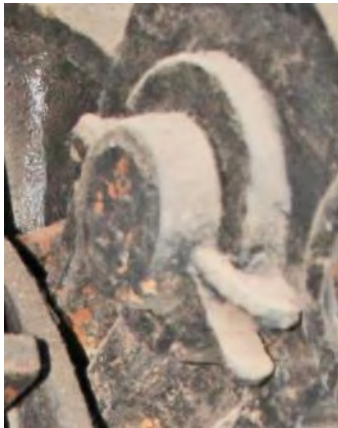
The plain crankpins, on the front left and rear right wheels, are $2\frac{1}{2}$ in diameter where they emerge from bosses on the backs of their wheels for a length of $\frac{7}{8}$ in and are secured by split pins. These pins appear to have been only 2 in diameter previously but then had sleeves shrunk on. At the fronts of these wheels, the pins have 3 in diameter ridges $\frac{5}{8}$ in wide and are then turned down to $2\frac{1}{2}$ in diameter for $1\frac{3}{4}$ in to provide the connecting rod bearing surfaces. Outside the connecting rods the pins are of 3 in diameter, tapering down to 2 in over a length of 3 in before the $1\frac{1}{4}$ in diameter necks of the 2 in diameter spherical pins for the coupling rods.

Fig. 19.8. Crankpin attachment at the back of the front left wheel.

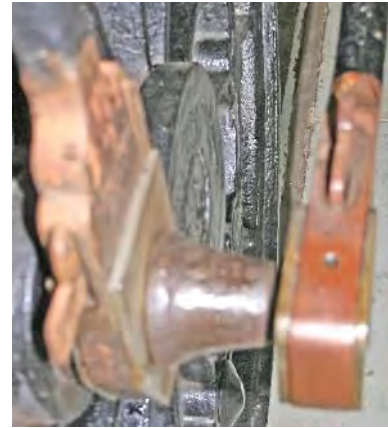
Fig. 19.9. Plain crankpin with taper between bearing brasses on front left wheel.

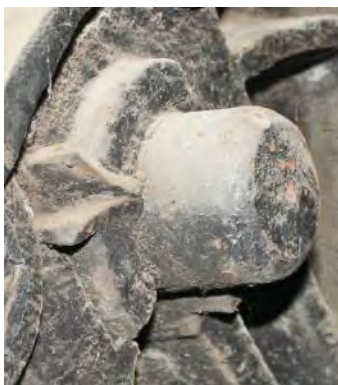
The crankpins with return cranks, on the front right and rear left wheels, protrude further through the wheels. The protrusion behind the front right wheel is $2\frac{1}{2}$ in diameter and $1\frac{1}{2}$ in long whereas that on the rear left wheel is 3 in diameter and 2 in long. In both cases the pin is secured by a cotter which also keys into the boss at the back of the wheel, but the main precaution against the pins turning in their wheel sockets is provided by them being keyed into their wheels.

Fig. 19.10. Crankpin attachment at back of front right wheel.

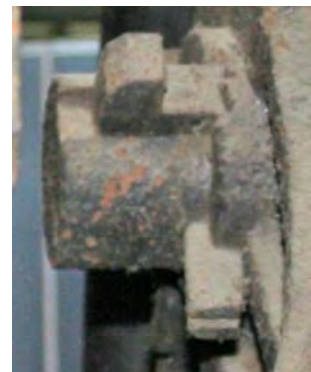
Fig. 19.11. Crankpin attachment on back of rear left wheel.

The size of the crankpin where it passes through the wheel boss is 20% larger on the rear left wheel than on the front right wheel. This increase could have been to allow for an increase in the torque to be withstood with that particular wheel, when it was made, or to give added security with the same torque.

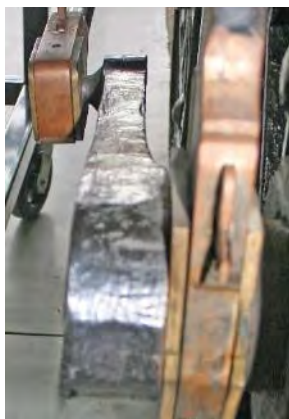
Outside the wheels, these crankpins provide bearing surfaces for the connecting rods, as for the plain pins, in the gaps between the return cranks and the wheels. The return cranks themselves are 16.97 in between centres and are orientated so that the (spherical) return crank pins are 90° round the wheels from the main crankpins and at the same 12 in radius from the wheel centres. The return cranks are $4\frac{1}{2}$ in diameter at the crankpin ends tapering down to $2\frac{1}{4}$ in before the 3 in diameter ends carrying the 2 in diameter spherical return crank pins for the ball-joint connections to the connecting rods. The necks of these pins are $1\frac{1}{4}$ in diameter. The return cranks are 2 in thick at the crankpin ends reducing to $1\frac{1}{2}$ in thick at the ball-joint ends.

Fig. 19.12. View from rear of return crank on rear left wheel.

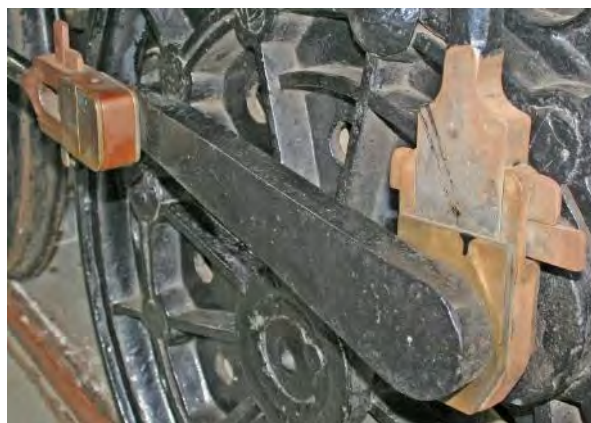
Fig. 19.13. Three quarters view of return crank on rear left wheel.

Centres punched into the fronts of the return cranks in line with the main crank pins indicate that the return cranks were forged in one piece, with the turning of the pins being carried out on a large lathe.

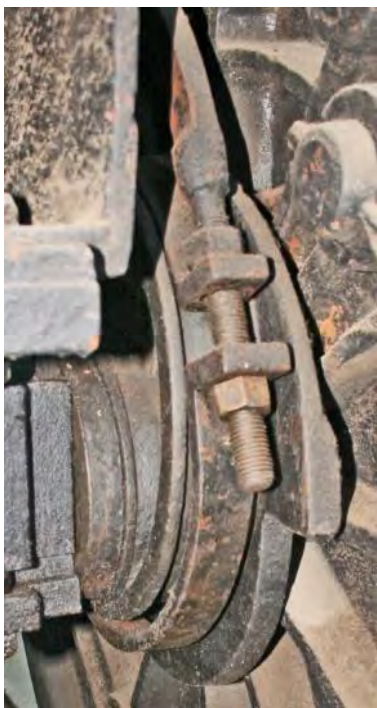
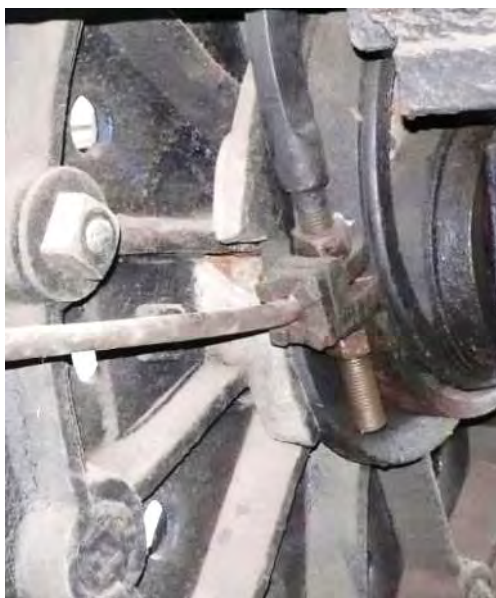
The cast iron eccentric is located between the front left wheel and its axle-box. It is a running fit on the axle and provides a surface $12\frac{1}{2}$ in diameter and 2 in wide for the strap, with shoulders $\frac{3}{8}$ in wide by $\frac{1}{2}$ in high. It has an eccentric circle diameter of 5 in. The integral catch plate has a smaller diameter of 15 in and a larger diameter of $18\frac{1}{2}$ in, which extends for 180° . It is generally $\frac{1}{2}$ in thick, increasing to $\frac{7}{8}$ in thick at the ends. The overall width of the eccentric is therefore only $3\frac{1}{2}$ in.

The eccentric was driven by a 'catch' bolted to the back of the wheel (Figs. 20.2 and 20.5), acting on either of the radial edges of the catch-plate, as pertinent for the direction of travel. The width of the catch should reflect the degree of cut-off required, with a catch of zero width being associated with 100% cut-off. A 90% cut-off would have required a catch width of around 5 in, whereas the original width of the catch was around 7 in, corresponding to a cut-off of nearer 80%. However, the cutting away of the leading edge of the catch may have been to correct this for forward motion.

Fig. 20.5. Rear of eccentric, with integral catch plate and ball-joint housing on strap. Eccentric catch behind and below ball-joint housing. Securing bolt partly obscured by eccentric rod.

Fig. 20.4. Front of eccentric, with integral catch plate and strap.

The eccentric rod is significantly bent at the eccentric end (Figs. 20.2 and 20.5). This was necessary for the rod to be able to connect with the bell-crank in its existing position, as discussed further below.

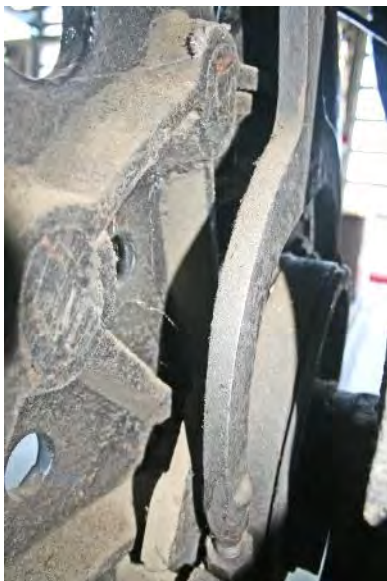
Fig. 20.6. Forked bottom end of front cylinder valve drive.

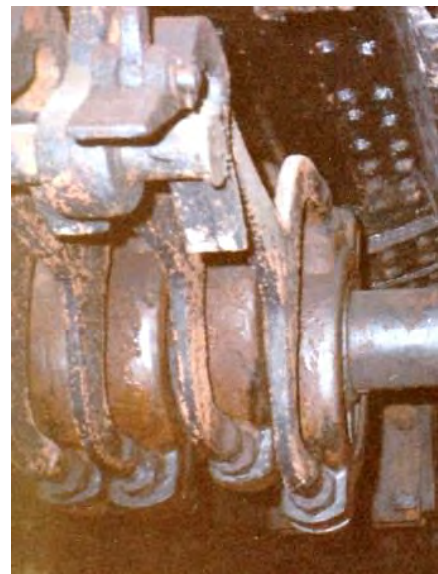
Fig. 20.7. Forked eccentric rods on *DERWENT*.

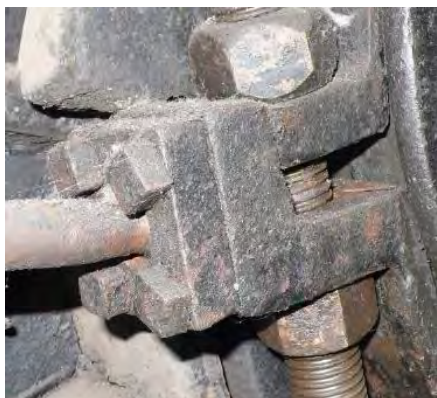
The valve drive to the rear cylinder is indirect. The eccentric strap has half of the ball housing, 2 in square in section, formed on its lower half. The other half of the ball housing is bolted to it, capturing a $1\frac{1}{2}$ in diameter ball formed at the end of the $\frac{5}{8}$ in diameter eccentric rod. The other end of the eccentric rod has what is effectively a universal joint, comprised of a clevis and a short link for connecting to a bell-crank. The clevis is of cast iron and is screwed to the end of the eccentric rod. This allows adjustment of the effective length of the

Fig. 20.8. Eccentric rod ball-joint housing.

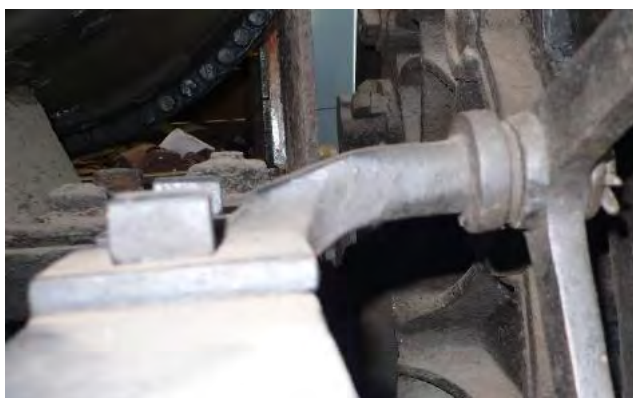
rod. The distance between the ball centre and the centre of the pin on the bell-crank is $22\frac{3}{4}$ in, putting this pin centre some 34 in from the eccentric centre.

Fig. 20.9. Eccentric rod clevis, bell-crank and pivot.

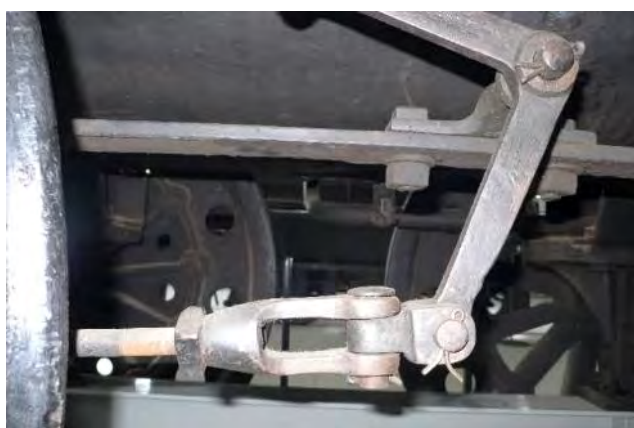
Both arms of the wrought iron bell-crank have distances between centres of $7\frac{1}{2}$ in. The arms are generally $\frac{1}{2}$ in thick, but $\frac{3}{4}$ in thick at the ends and centre. The bell-crank rotates on a forged pivot whose centreline is $1\frac{1}{2}$ in above the wrought iron bar to which it is bolted and 35 in behind the front axle centre. This 3 in wide by $\frac{1}{2}$ in thick bar is supported at each end by the adjacent boiler support brackets.

Fig. 20.10. Bell-crank pivot with bell-crank on the right.

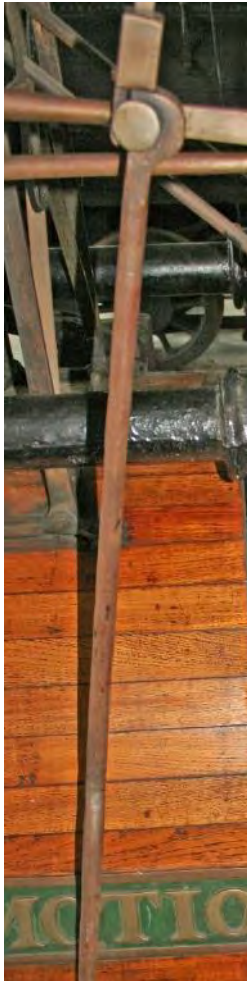
The valve drive rod for the rear cylinder (Fig. 20.11) rises diagonally from the top arm of the bell-crank. This rod is of wrought iron $\frac{3}{4}$ in diameter and 69 in long between the centre of the clevis pin on the bell-crank at its lower end and the centre of the pin on a lever to which it connects at the top. This rod is doglegged out below the boiler centreline to clear the side of the boiler and doglegged back above the centreline.

Fig. 20.11. Rear valve drive rod rising diagonally. Locking sleeve engaged.

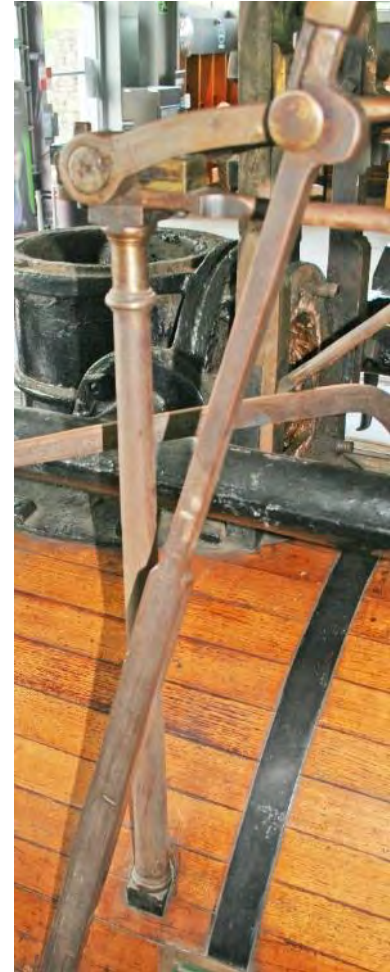
Fig. 20.12. Forward eccentric rod/valve drive rod rising diagonally. Locking sleeve disengaged.

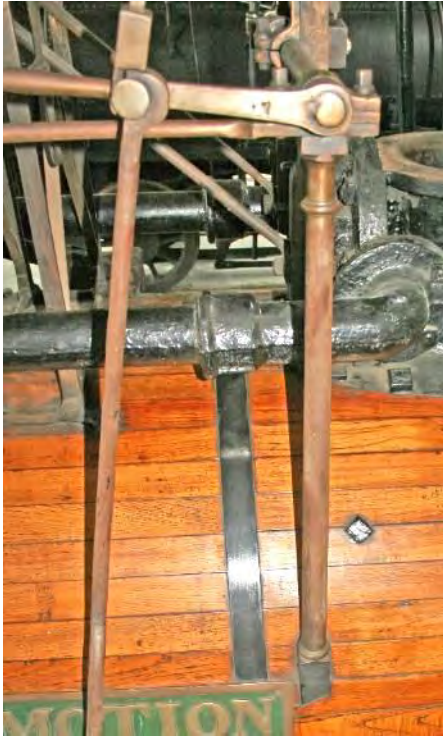
Fig. 20.13. Upper part of front valve drive rod, with pin on lever, and disengaged pin locking sleeve.

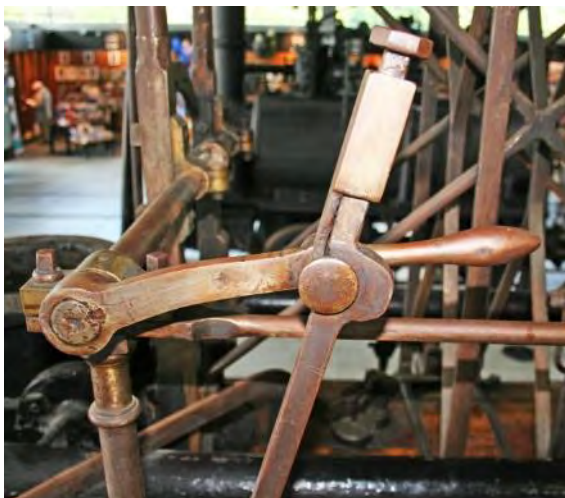
The levers actuated by the valve drive rods are keyed to rocking shafts. These levers are $\frac{1}{2}$ in thick and have effective lengths from the centres of the pins to the centres of the rocking-shafts of $7\frac{1}{2}$ in. The levers are extended to provide handles. The front cylinder lever has been significantly bent, so that the pin is about 2 in lower than it would have been if the lever was straight. This is discussed further below.

Fig. 20.14. Rear valve drive rod, lever and stanchion.

These levers actuate rocking-shafts. Each $1\frac{1}{4}$ in diameter rocking-shaft is located in a bronze bearing which is supported by a stanchion bolted to the side of the boiler. There are two such stanchions, one for each rocking-shaft, with their centres $35\frac{1}{2}$ in apart (Fig. 20.2). In the area of the bolts securing the stanchions to the boiler these stanchions are $\frac{3}{4}$ in thick and 2 in wide, changing to 2 in square above this area. The stanchions are then machined to $1\frac{1}{2}$ in diameter tapering to $1\frac{1}{4}$ in diameter below the bearings. The stanchions are connected by a $\frac{3}{4}$ in diameter bar (Figs. 20.2 and 20.14).

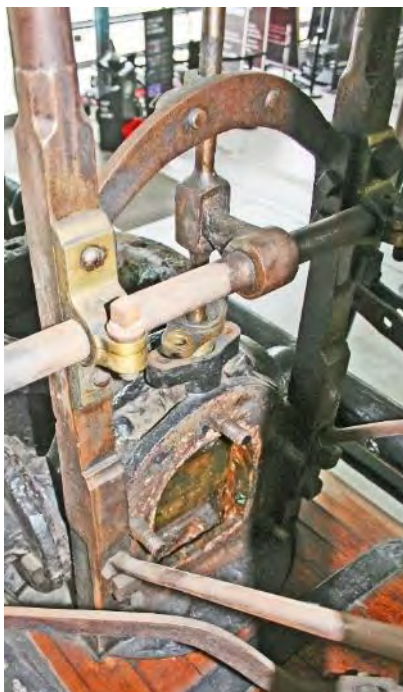
Each rocking-shaft is also located in two further split bearings, with each such bearing bolted to a column. These columns are $1\frac{5}{8}$ in square-section at their lower ends, changing to $1\frac{3}{8}$ in diameter above the split bearings, where the columns rise further to support the parallel motion (Section 19). The columns are supported by extensions on the valve-chest, and have tongues, $7\frac{1}{2}$ in long and $\frac{3}{4}$ in thick, stretching over the faces of the extensions, to which they are bolted. These valve-chest extensions consist of square-section pillars rising vertically either side of the valve-chest cover, with a nominal separation of 12 in. They originally ended some 3 in above the rest of the valve-chest casting, but all except one of these extensions (that on the rear valve-chest, right-hand side) have apparently broken at their roots, with the breaks being filed flat and the columns modified to suit. The net result is that the centres of these rocking-shafts are $21\frac{1}{4}$ in above the boiler crown and $13\frac{3}{4}$ in from the cylinder centrelines.

Fig. 20.15. Columns, rocking shaft and split bearings for front cylinder valve gear.

The tops of the valve-rods are guided by bearings bolted to the tops of arch-shaped forgings, in turn bolted to the inner faces of the columns (Figs. 20.15 and 20.16). Below the lever cavities the rods pass through glands on the tops of the valve-chests (Section 17) and are then screwed into the tops of the slide-valve buckles, with locking-nuts.

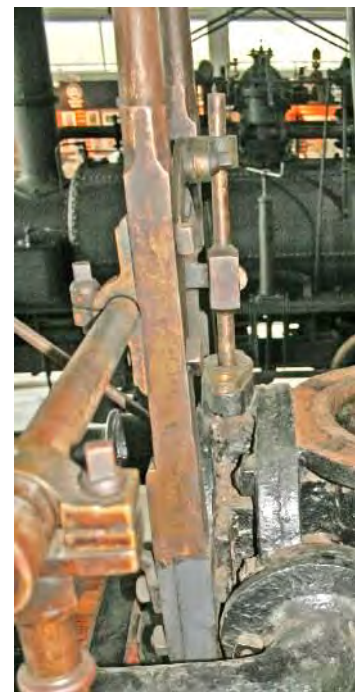
Fig. 20.16. Column bolted to rear valve-chest extension.

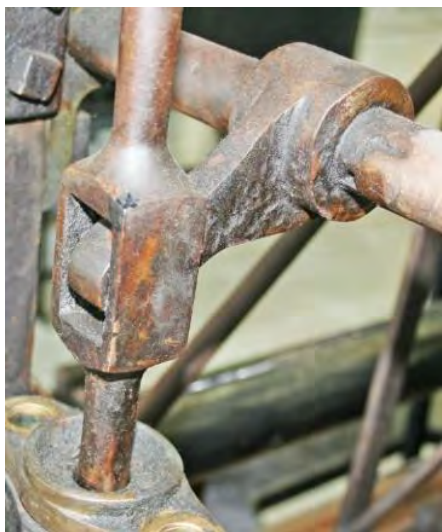
The rocking-shafts carry round-ended levers midway between the split bearings. These cast iron levers have lengths between centres of $3\frac{5}{8}$ in. The levers are generally $\frac{1}{2}$ in thick, increasing to $1\frac{1}{2}$ in wide on the shafts, and 1 in wide at the 'blind' round ends. The 'blind'

ends operate in cavities formed in the valve-rods. These cavities are just over 1 in wide, $1\frac{3}{4}$ in high and $1\frac{1}{4}$ in from front to back, with the valve-rods being $\frac{3}{4}$ in diameter. Horizontally, the centres of the valve rods are $3\frac{1}{2}$ in from the rocking-shaft centres and $9\frac{3}{4}$ in from the cylinder centres.

Fig. 20.17. Rocking-shaft, round-ended lever, and valve-rod for front cylinder.

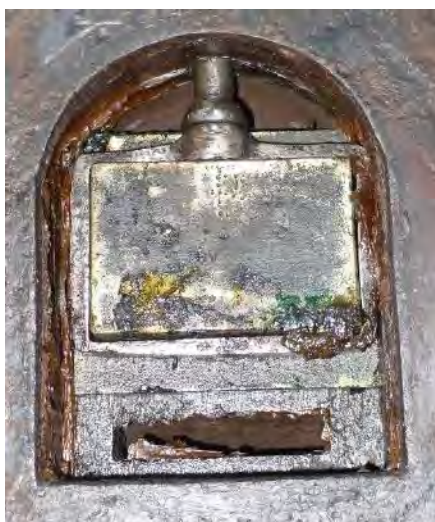
Fig. 20.18. Slide-valve and buckle on rear cylinder (raised to expose lower steam port)

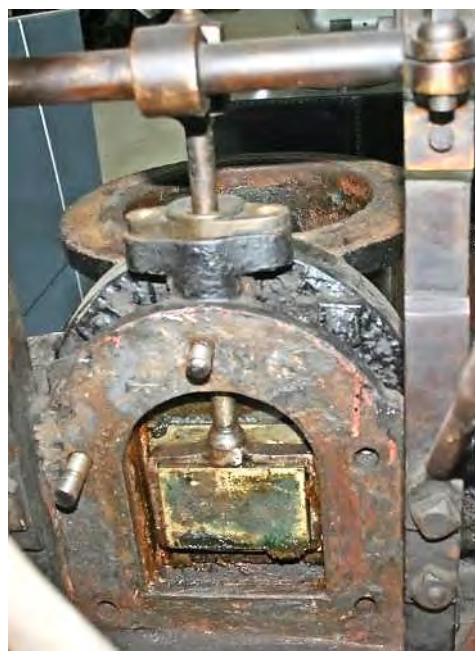
Fig. 20.19. Valve-rod, slide-valve and buckle on rear cylinder.

The buckles are of wrought iron and measure $5\frac{3}{4}$ in wide by 4 in high externally, with wall thicknesses of $\frac{3}{8}$ in. They are a close fit round the backs of the cast bronze slide-valves. These valves have port-face contact areas $5\frac{1}{2}$ in high and 6 in wide, with internal openings estimated to be 3 in high and 4 in wide. The back of the valve for the rear cylinder is stamped 'BV'. The port-faces are $7\frac{1}{4}$ in high and 6 in wide and are further described in Section 17.

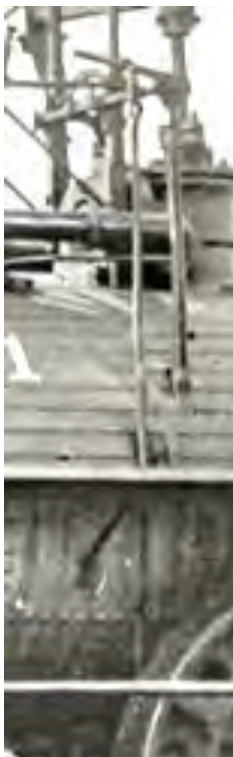
It is very likely that this was because, during the restoration, the top arm of the bell-crank was incorrectly set to point to the right when the valve drive rod was attached, leaving the rod almost vertical, so an adjustment was not considered necessary. This error, which would have left the locomotive inoperable, is apparent in the photograph, taken shortly after the restoration, which shows the rod emerging from behind the rear wheel. The error supports the proposed previous configuration shown in blue (Fig. 20.2), which also has the rear valve drive rod almost vertical. It is likely that the Shildon Works team merely repeated the previous configuration thinking it would be correct.

Fig. 20.20. Rear valve drive rod set vertically. [Fig. 8.1 – detail]

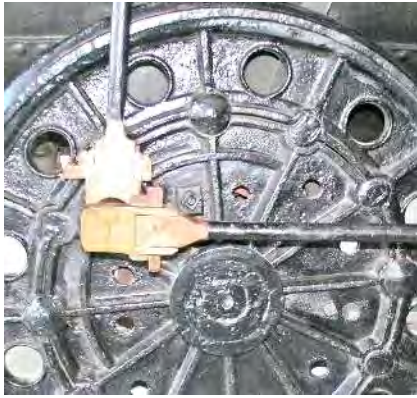
Fig. 20.21. Bolt holding eccentric catch at 17 minutes past, and bolt clamping eccentric catch-plate to wheel at 3 minutes to top of wheel. Both bolts in wheel centre.

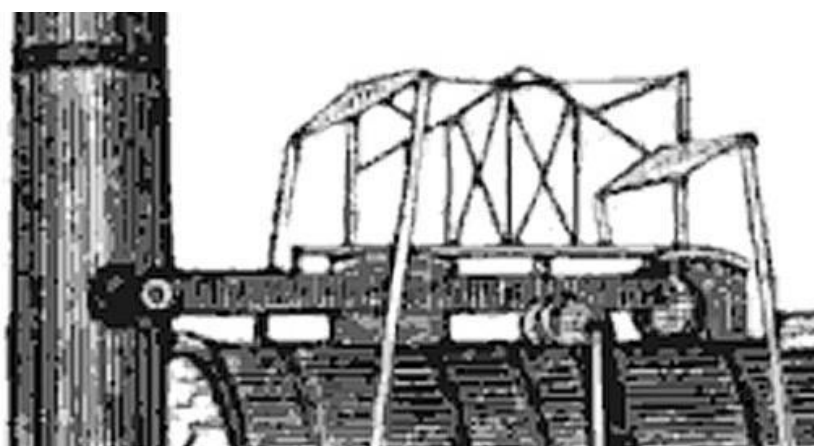
The earliest representation of the Stephenson locomotives on the Stockton & Darlington line suggests that a single exhaust pipe, shown on the left side of the boiler centre-line, was fitted in 1825. This followed the practice of the Killingworth-type locomotives operating on the Killingworth, Hetton and Mount Moor lines.

Fig. 21.1 Early S & D R locomotive, showing the exhaust pipe.

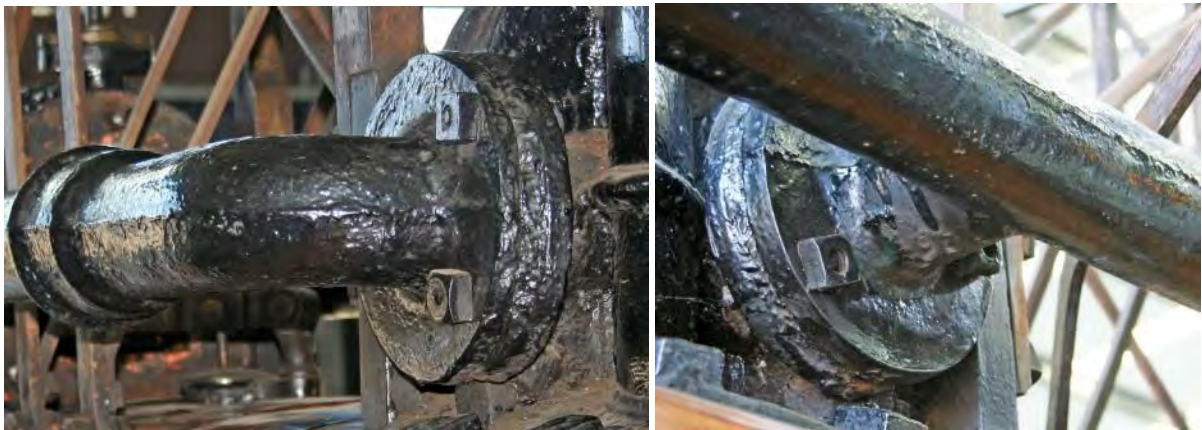
Fig. 21.5 Left-side, rear cylinder casting flange (left) and front cylinder casting flange (right).

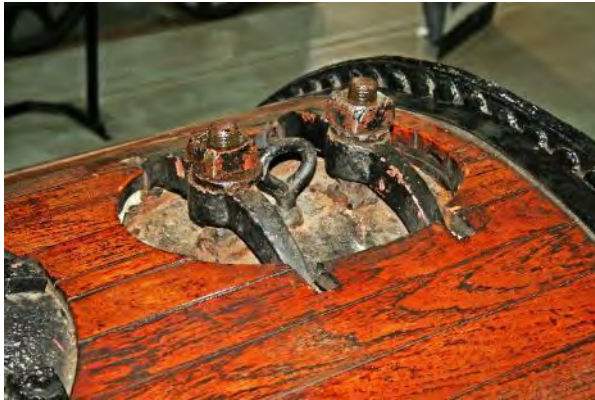
An oval inspection hatch is inserted into the rear of the boiler crown, its rearmost point being some $4\frac{1}{8}$ in from the backplate angle iron's leading edge. The oval opening has a maximum length of $15\frac{1}{4}$ in, and maximum width of $10\frac{7}{8}$ in.

Fig. 22.1 Inspection hatch and cover

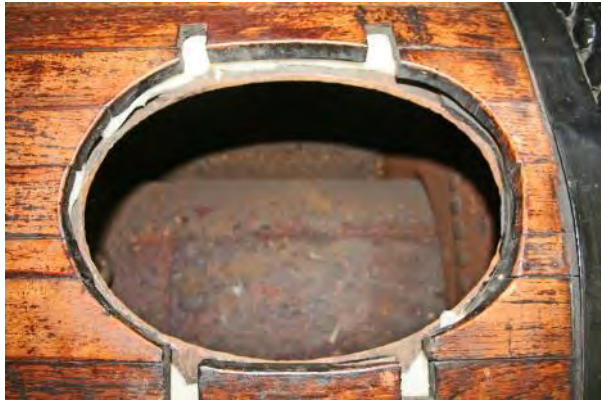
Fig. 22.2 Inspection hatch with cover removed

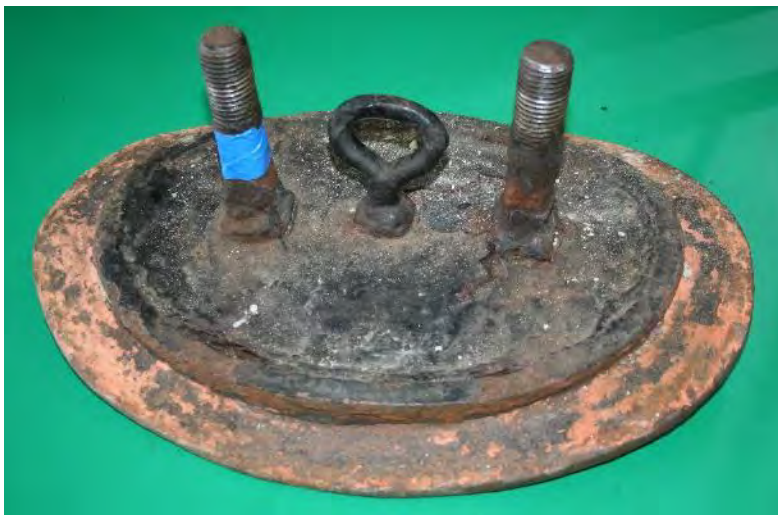
Fig. 22.3 Inspection hatch cover

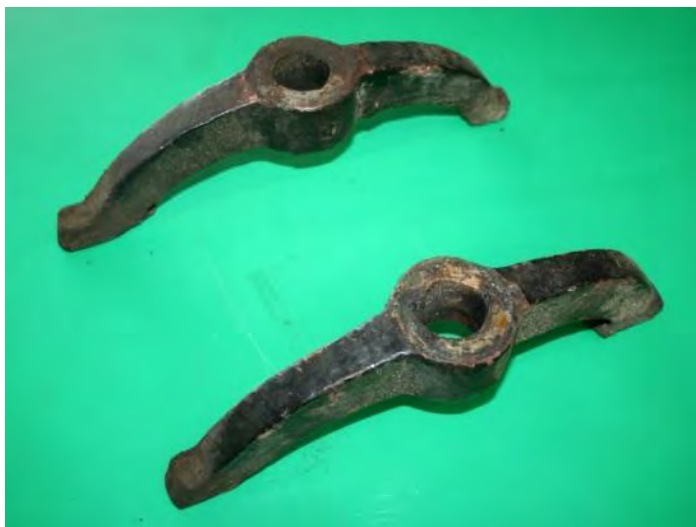
The two cast iron bridge arms are 13 in long, with a maximum width of $1\frac{1}{2}$ in, and an overall height of $3\frac{3}{4}$ in. The arms are tapered from $\frac{3}{4}$ in to 1 in wide. The bolt hole is $1\frac{1}{2}$ in diameter and the nuts are $2\frac{1}{8}$ in A/F.

Fig. 22.4 Inspection hatch bridge arms

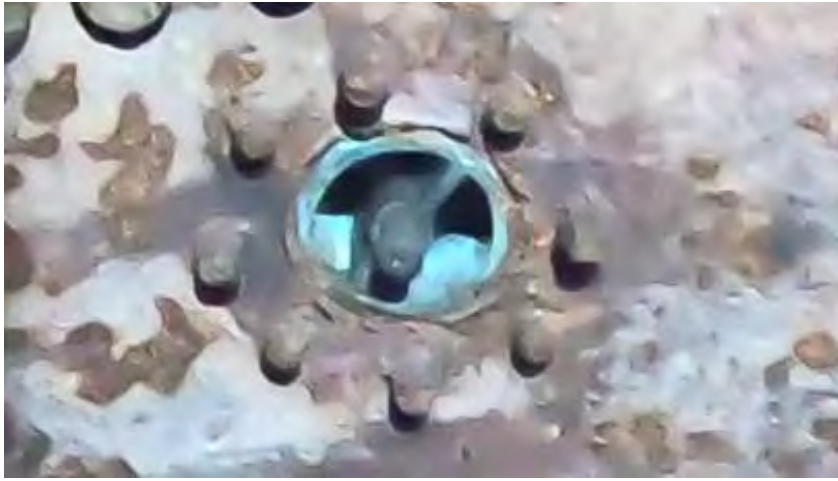
Fig. 22.6 Interior boiler view of safety valve

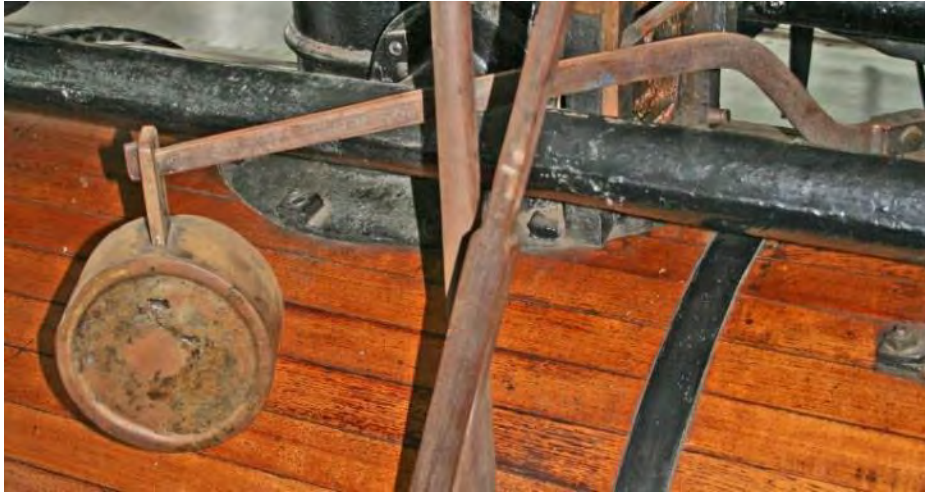
Fig. 22.8 Safety valve lever arm cranked over the exhaust pipe, with circular weight

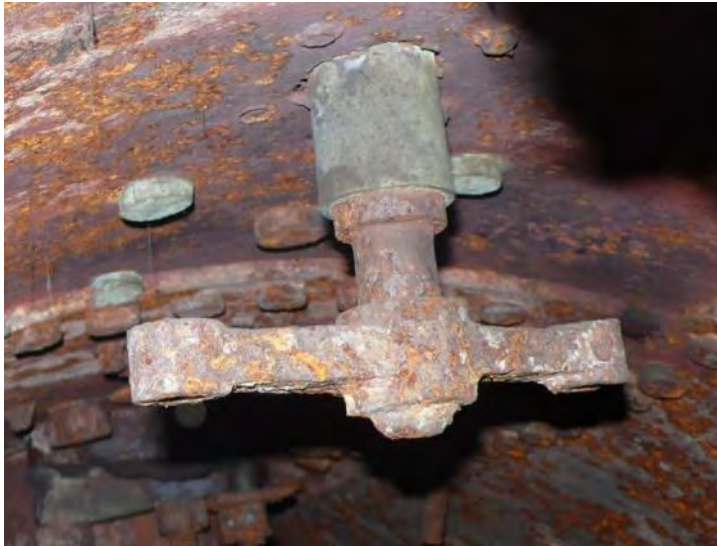
Fig. 22.10 Interior view of the double-ended lever and stuffing box.

The right-hand arm of this double-ended lever would have been connected to the front cylinder regulator valve and the left arm to the rear by rods.

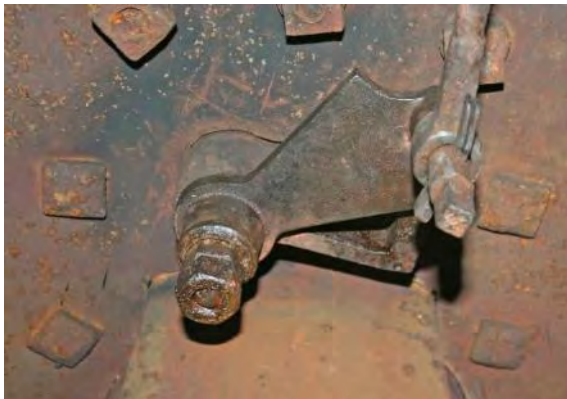
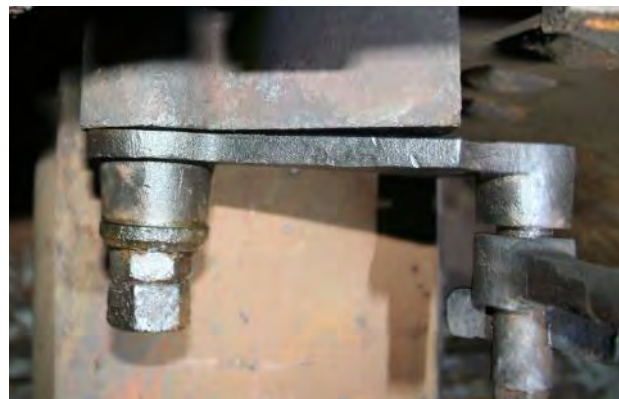
The arrangement is very similar to the design of the regulators on the Killingworth Colliery locomotive fleet, including Killingworth *Billy*. On the front steam chest the valve pivot is to the left and the spindle that connected the valve to its operating rod is to the right. The reverse arrangement applies to the rear steam chest because the steam chest castings are not handed. It is apparent that, with this arrangement, the driver, on his seat, would have moved the regulator lever away from himself to open the regulating valves and towards himself to close them. There would probably have been a pair of stops, fixed to the boiler shell, to define the fully open and fully closed positions.

Two views of the steam regulator valve on the front cylinder of Killingworth *Billy*:

Figs. 22.11 Upwards view revealing segmental steam passage and 22.12 Side view showing pivot and linkage.
[Killingworth *Billy* report 2018, Fig.15.5]

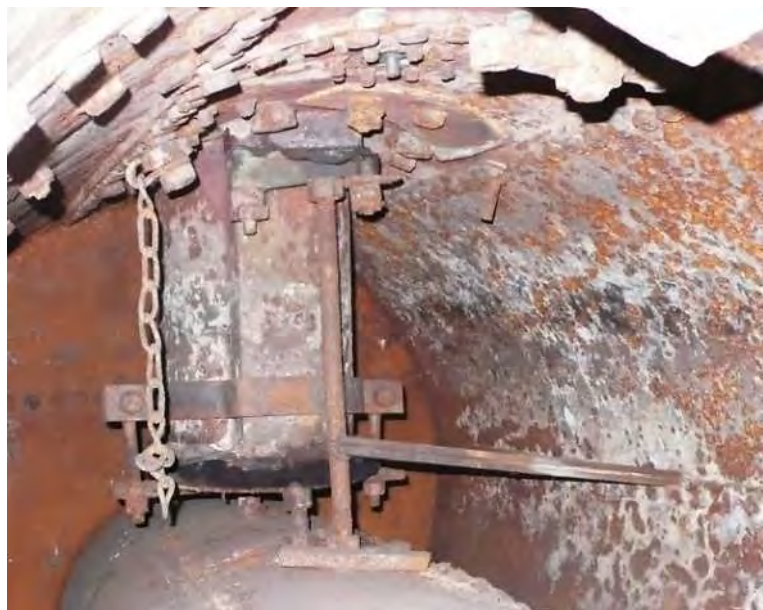
Fig. 22.14 Interior view of the front cylinder showing the regulator valve arm, prop and stay

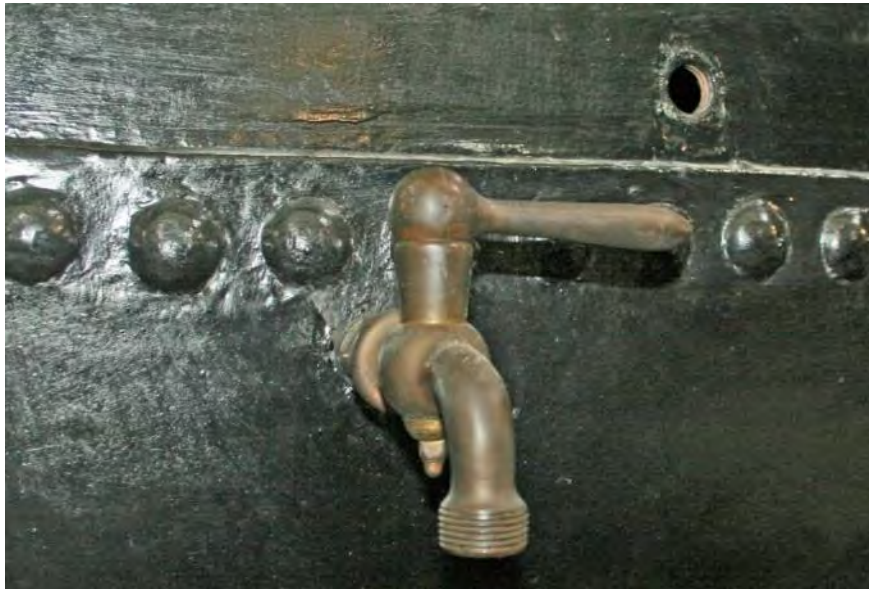
Fig. 22.15 The lower try-cock on the boiler back-plate, together with the hole of the upper try-cock.

The backplate carried two try-cocks, one of which is now missing (Section 22). The centres of these try-cocks are $1\frac{1}{2}$ in above and 3 in below the backplate join line, and $10\frac{1}{2}$ in and $16\frac{1}{4}$ in to the left of the backplate vertical centreline. The lower try-cock is a nominal 4 in above the top of the flue.

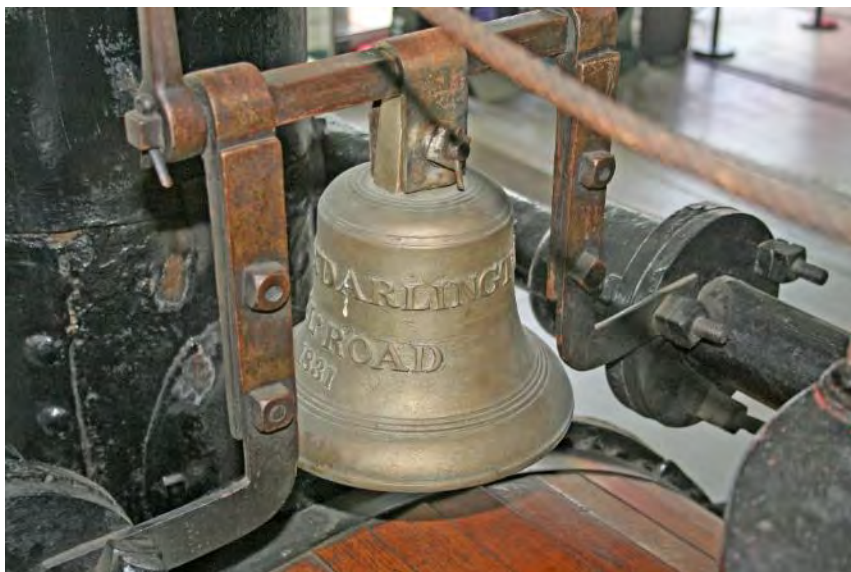
The bell is suspended from an iron rocking-shaft that can rotate within a pair of upright brackets. The brackets are secured to the adjacent exhaust pipe flanges. At the left side of the rocking-shaft an upright handle is fitted and secured by a split-pin, the top of which is formed into a ring, to which is tied a bell-chord that trails back to the driver's seat. When pulled, the handle would rotate the rocking-shaft causing the bell to oscillate and its clapper to chime.

Fig. 22.16 Brass bell mounted above the leading end of the boiler barrel

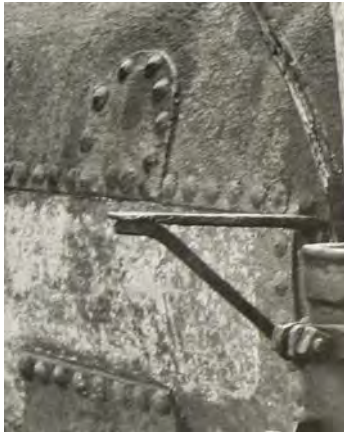
There is no evidence available that indicates the form of boiler feed-pump in use after 1828, when the new double return-flue boiler was used. The 1834-fitted boiler, still carried by *LOCOMOTION*, has a clack-valve opening on the right side of the boiler, approximately 7 in forward of the rear cylinder centreline and positioned above the running board. The opening could not be reached to measure it, because of the cladding presence, but the c2 in hole has been covered over with a 'tunnel'-shaped plate, c7 in wide and c9 in high, using eleven rivets.

Fig. 23.2 Former clack-valve opening, covered by a plate.

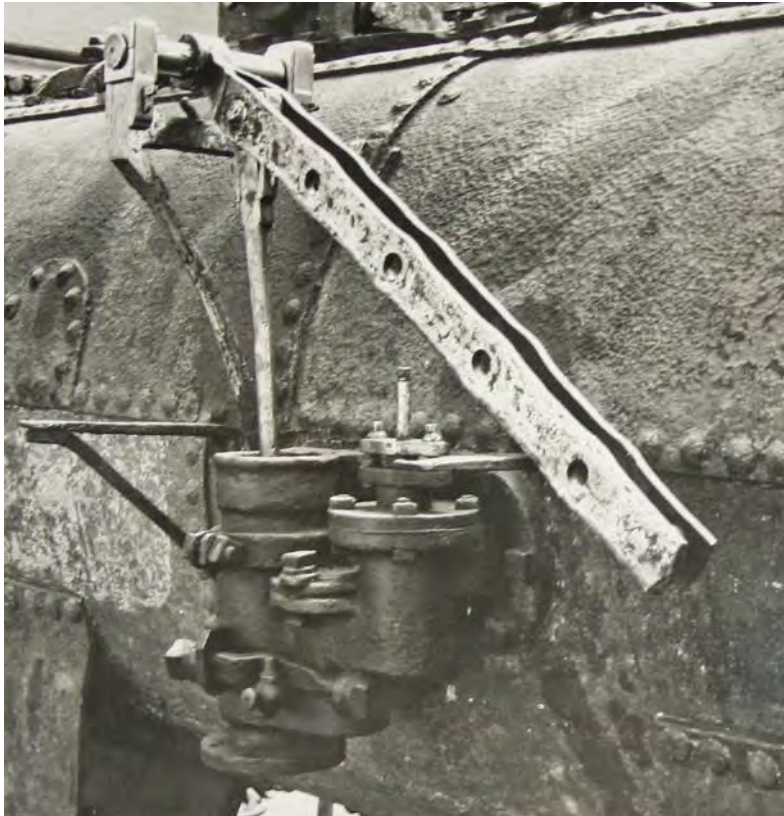
Fig. 23.3 1961 view of the surviving water feed-pump and operating lever arm.

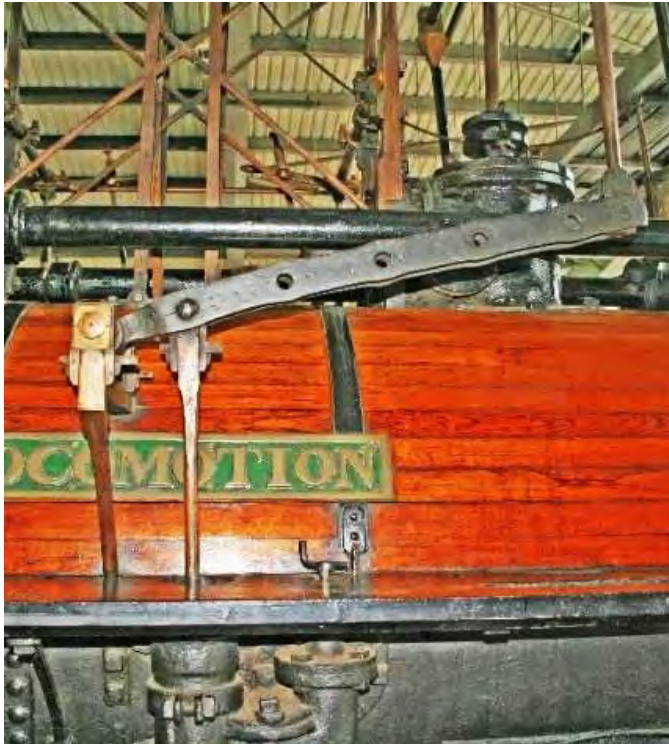
Fig. 23.5 Boiler feed-pump, pump rod, lever arm and connecting rod.

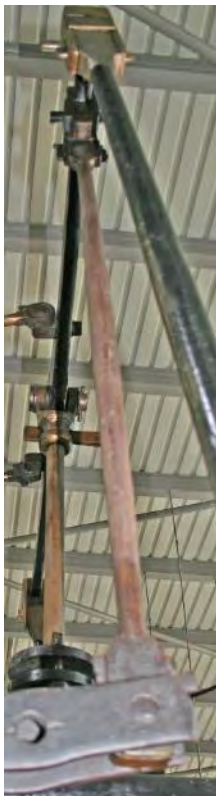
Fig. 23.7 The connecting rod pivot fitted beneath the front crosshead

A 1 in diameter hole has been drilled at the upper end of the lever arm to accommodate a $2\frac{5}{8}$ in long pin fitted through the bottom of the connecting rod with a strap retained by a gib and cotter. The connecting rod has been fitted to a pivot beneath the crosshead to which it is attached by two straps secured by gibs and cotters. The centre-line of the pivot is $3\frac{1}{2}$ in below the centre-line of the crosshead. The connecting rod is $42\frac{1}{2}$ in long between the centres of its top and bottom pivots, and is broader at its centre ($\frac{13}{16}$ in) than its ends ($\frac{7}{8}$ in).

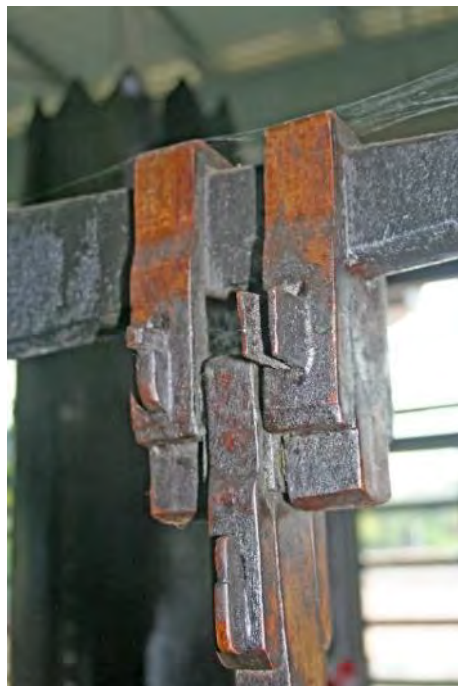
Fig. 23.6 The connecting rod fitted between the crosshead and the lever arm.

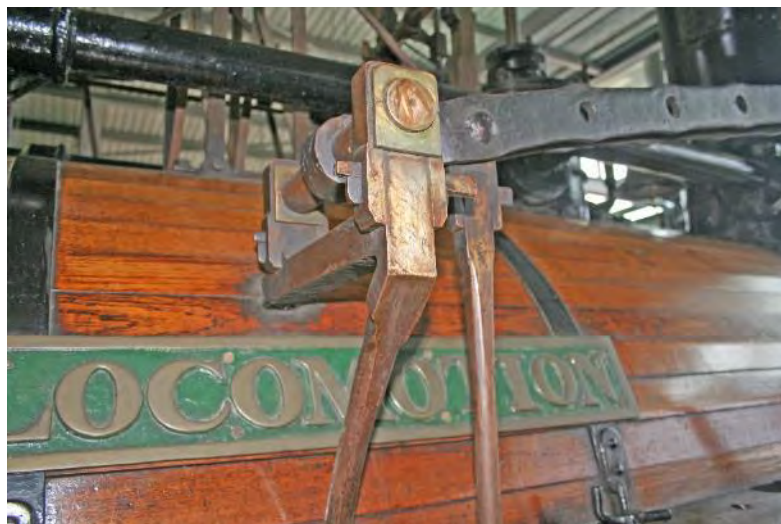
Fig. 23.8 Rocking shaft bracket

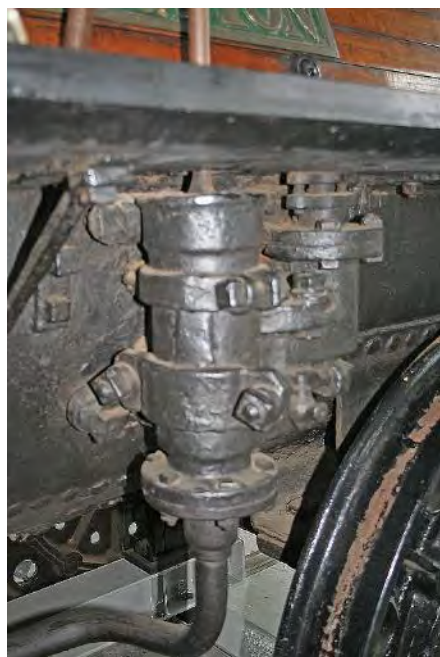
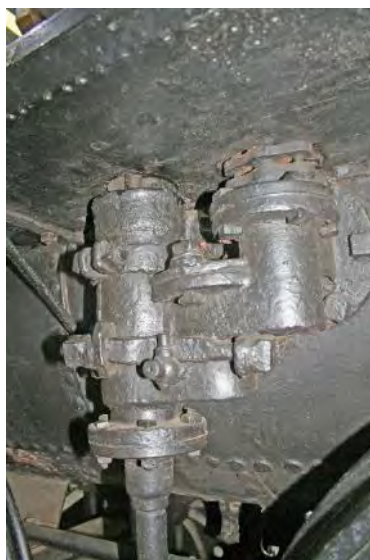
Fig. 23.10 Rearward view of feed-pump

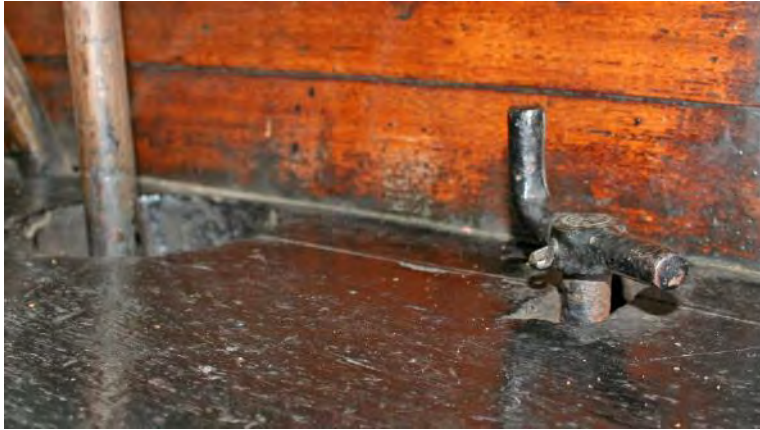
The feed-water hole in the boiler is c19¼ in behind the front cylinder centreline and is c2 in diameter. The clack valve body has a diameter of 4 in and height of 5 in. The clack valve flange faced onto the boiler is circular, about 6 in diameter held in place by six ½ in bolts. It is ¾ in thick, the use of filler material compensating for the curvature of the boiler. The clack valve body is surmounted by a 6½ in diameter x ¾ in thick flange. This top flange carries a gland around a shaft for the screw-down facility on the clack valve, to isolate the boiler from the boiler feed system. A handle at the top of this shaft is located above the running-board which allowed the crew to alter it as required.

Fig. 23.11 Handle for clack-valve screw-down facility.

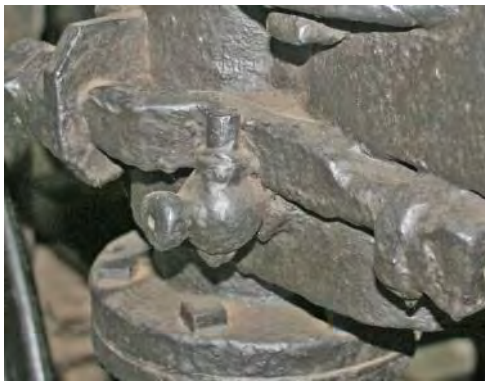
Between the pump body and the clack-valve body water was drawn through an intermediate passage which is 4 in wide and 3 in high externally. A bleed-valve is fitted to this passage, which is 1½ in diameter, but there is no surviving operating lever for it.

Fig. 23.12 Bleed-valve fitted to the side of the intermediate passage.

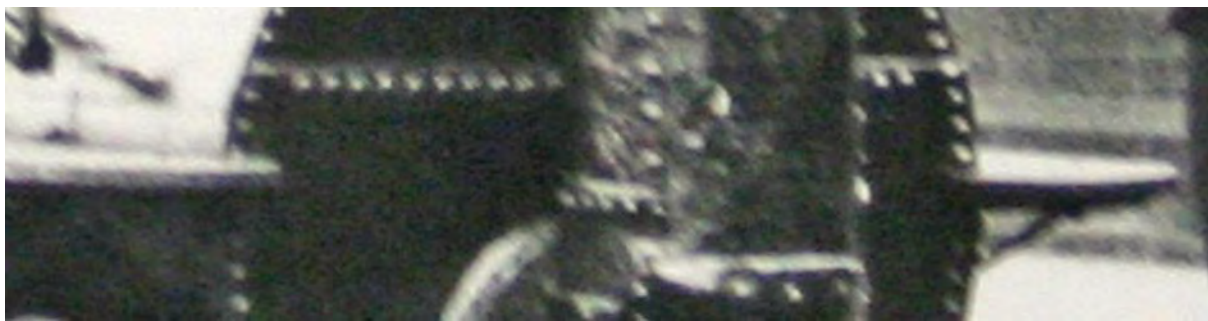
The Boards appear to have been replaced since 1906 on at least one occasion. Photographs of the locomotive have usually been taken as broadside views, thus making it difficult to determine the end profiles of the Boards. However, the front view of the artefact taken in 1925 shows that full width Boards with rounded ends had been employed on that occasion, and it is possible that they had been installed, new, during the locomotive's restoration in 1924.

Fig. 24.3 1925 view of the centenary parade train. The leading ends of the running-boards are extended beyond the boiler front-plate with rebates for the angle irons. [NRM Historic Photos. – file 812]
