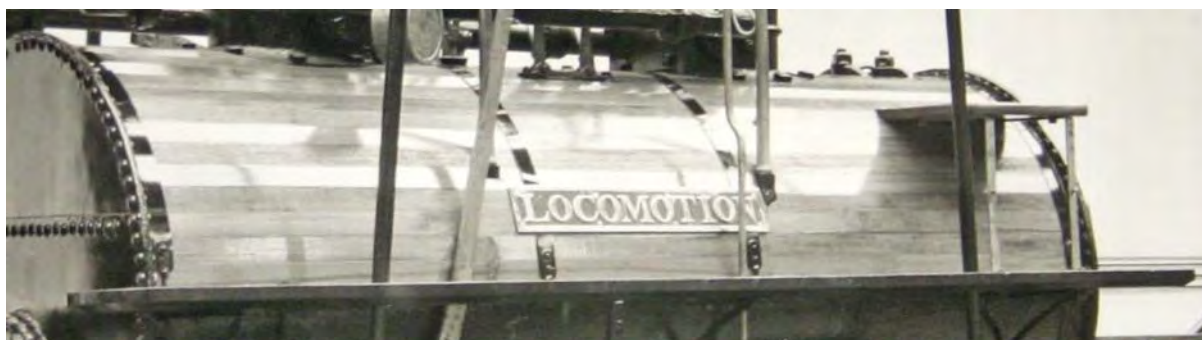
The cladding was removed during the locomotive's refurbishment at the Darlington Locomotive Works in 1961. It is apparent that fresh oak cladding was supplied and installed. Although evidence to confirm this has not been traced, photographs taken after the refurbishment appear to show fresh timber. Following the application of the boiler's coat of protective paint, the cladding was fitted over the upper half of the boiler barrel in the paint shop at Darlington, and coats of varnish were applied to its surface.

Fig. 24.4 Freshly varnished cladding fitted to *LOCOMOTION* in June 1961 on the conclusion of its refurbishment in Darlington Locomotive Works. [York HQ Photos, Box 9, No. 8792]

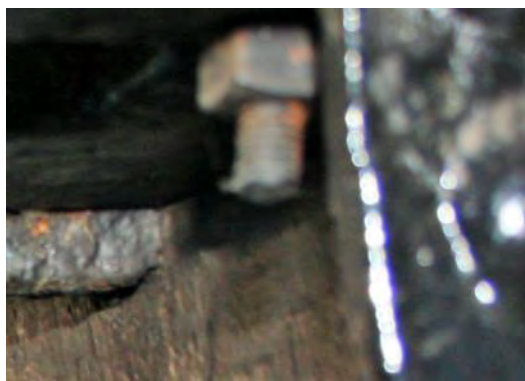
Fig.24.5 The left-side rear retaining clasp above and below the running-board.

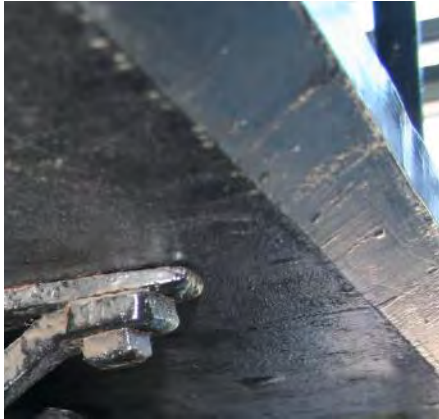
The left-side board is 11 ft 8 in long, whilst the right-side board is 11 ft 9¼ in long. Both are 2 in thick and 1 ft 3½ in wide for their entire length, with rebates to accommodate the boiler-end angle irons. Their front ends are 9½ in ahead of the front of the boiler. They are chamfered on the underside around the perimeter, with the rim protected by an iron or steel band along its length. It is likely that the 1906 apprentice drawing has simplified the arrangement of the boards, showing only the 1 ft 9 in long openings for the two connecting rods.

Fig. 24.6 Underside of the right-side running-board, showing chamfered edge.

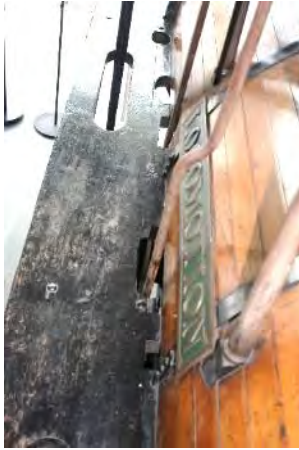
The fifth hole, again formed adjacent to the boiler plates, is that inserted to accommodate the rear valve rod. It is $10\frac{1}{2}$ in long by 4 in wide, again with rounded ends. Its mid-point is 5 ft $8\frac{1}{4}$ in from the front of the running board.

The sixth hole is small and rectangular, adjacent to the boiler plate, and is $2\frac{3}{8}$ in long and $2\frac{3}{4}$ in wide. Its mid-point is 6 ft $6\frac{3}{4}$ in from the leading end of the running-board. It is not evident what the purpose of this hole might have been.

Fig. 24.7 Left-side running-board facing forwards, showing the leading six holes.

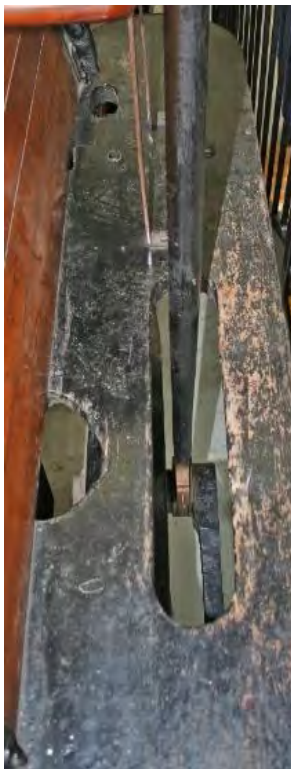
The seventh hole is an arc adjacent to the boiler plate that has a maximum length of 8 in and a maximum width of $3\frac{3}{4}$ in. Its centre is some 8 ft from the front of the running-board. It would have accommodated a lifting sling for the rear of the locomotive.

The eighth hole allowed for the rear connecting rod to pass through. It is $22\frac{1}{2}$ in long and 4 in wide, with its centre some 8 ft $1\frac{1}{2}$ in from the front of the running-board and $9\frac{1}{2}$ in from its inner edge.

The ninth hole is $4\frac{1}{2}$ in long and $2\frac{1}{2}$ wide with rounded ends. Its centre is 10 ft $6\frac{1}{4}$ in from the front of the running board and $1\frac{3}{4}$ in from the inner edge. There is thus a $\frac{1}{2}$ inch separation from the outer surface of the cladding and would have been used for a narrow lifting sling.

Fig. 24.8 Left-side running-board facing rearwards, showing the seventh, eighth and ninth holes.

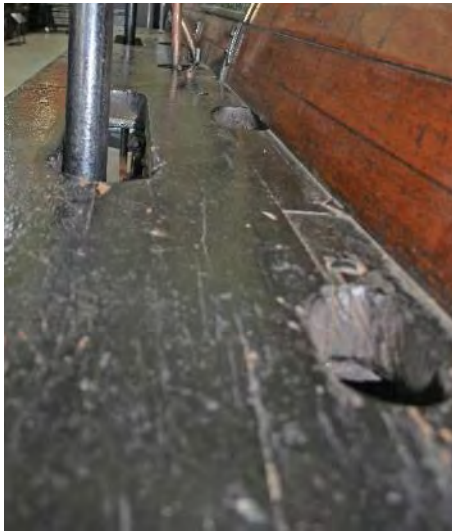
The second hole is an arc, with a maximum length of 7 in and a maximum width of $2\frac{3}{4}$ in. Its centre-point is 3 ft $4\frac{1}{4}$ in from the leading end. This hole matches the left-side hole No.2 and would have been used for lifting-slings.

The third hole accommodated the front connecting rod movement. It is $21\frac{1}{2}$ in long and 4 in wide, with rounded ends. Its mid-point is 3 ft 1 in from the leading end of the board and 8 in from the boiler plate.

Fig. 24.9 Leading end of the right-side running-board facing rearwards, showing the first, second and third holes.

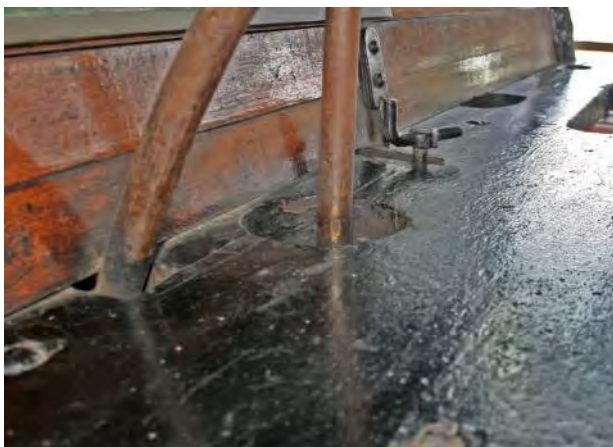
The 4th, 5th and 6th holes accommodate the boiler feed-pump components. The 4th hole is for the spindle for operating the screw-down clack-valve. It has a slot $4\frac{3}{4}$ in wide from the boiler plate and is 1 in deep, with its centre-point being 4 ft $7\frac{1}{2}$ in from the front of the running-board and $2\frac{1}{2}$ in from the boiler plate. The 5th hole is for the feed-pump arm and is circular with a diameter of $4\frac{1}{4}$ in. Its centre is 5 ft from the front of the board and 4 in from the boiler plate. The 6th hole is for a feed-pump pivot bracket. The 2in long hole is formed as a slot from the boiler plate, some $3\frac{3}{4}$ in deep. Its centre-point is 5 ft $8\frac{1}{4}$ in from the front of the board and $3\frac{1}{4}$ in from the boiler-plate.

Fig. 24.10 Right-side running-board from its mid-point facing forwards, showing the 4th, 5th and 6th holes for the boiler feed-pump components.

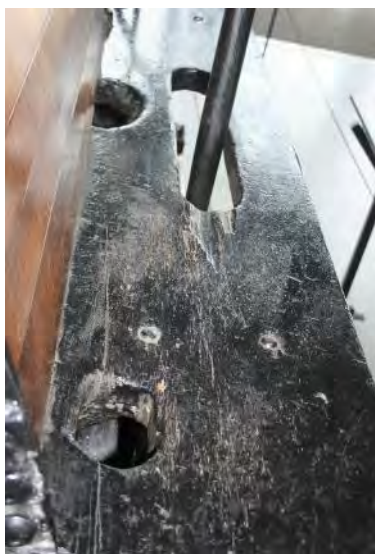
The 7th hole is in the form of an arc radiating from the boiler plate, with a maximum width of 4 in outside the cladding and a maximum length of $6\frac{3}{4}$ in. Its centre-point is 8 ft $5\frac{1}{4}$ in from the front and $4\frac{3}{4}$ in from the boiler plate. It would have been used for a lifting-sling, matching the 7th hole on the left-side running board.

The 8th hole is that made to accommodate the rear connecting rod. It is $21\frac{1}{2}$ in long and 4 in wide. Its mid-point is 8 ft $2\frac{1}{2}$ in from the front of the beam and $9\frac{3}{4}$ in from the boiler plate.

The 9th hole is oval, its maximum length being $4\frac{1}{2}$ in and its maximum width being $3\frac{1}{2}$ in. Its mid-point is 10 ft 6 in from the front of the running-board and $5\frac{1}{4}$ from the boiler plate. It would have been used for a lifting sling matching the left-side 9th hole.

Fig. 24.11 Rear of the right-side running-board facing forwards, showing the 7th, 8th and 9th holes.

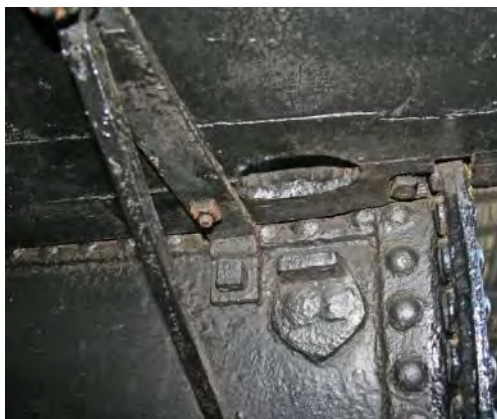
The brackets are mostly bolted to the boiler barrel using flanged extensions turned to face the boiler plates. On the left side these are above running board level, but on the right side they are below running board level, probably due to the boiler plate overlap. Two of the flanges for the right-side running-board are of an earlier 'heart'-shaped form with two adjacent rivets in horizontal alignment. The front bracket has been cut short and is redundant, whilst the rear one has been re-used for the bracket arm.

Fig. 24.13 Right-side front bracket, with redundant 'heart'-shaped flange to its right

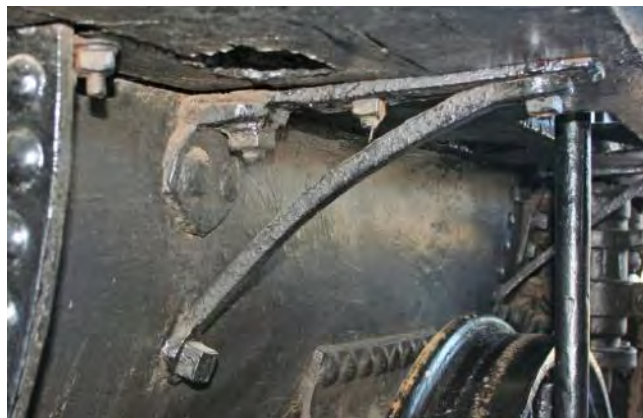
Fig. 24.14 Right-side rear bracket, with 'heart'-shaped flange supporting replacement bracket arm.

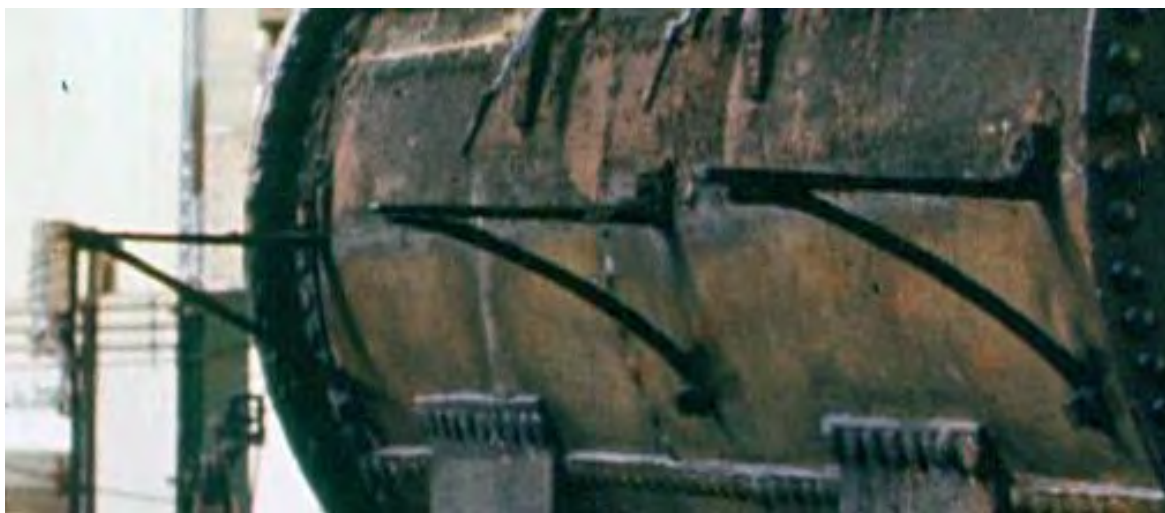
Fig. 24.15 Left-side forward facing view of the boiler, as photographed during the 1961 refurbishment, showing the running-board brackets bolted to the barrel.
[ARPT photograph - detail]

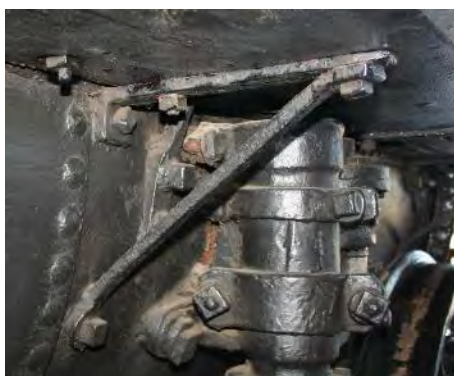
On the right-side, however, there are no similar photographs to check on the method of securing the brackets before 1961. The front right bracket is $13\frac{1}{2}$ in long x 2 in wide x $\frac{1}{2}$ in thick, supported by a 17 in long straight stay of $\frac{1}{2}$ in x $\frac{3}{4}$ in section. The central bracket has been relocated at some stage. The earlier bracket has been cut off leaving a lower 'palm' still bolted through the boiler. The surviving bracket, with a bolted flange, is $11\frac{3}{4}$ in long x $1\frac{3}{8}$ in wide and is tapered from $\frac{1}{2}$ in to $\frac{1}{4}$ in thick. Its diagonal stay, of $\frac{1}{2}$ in square section, is 15 in long. The rear horizontal bracket arm is not bolted to the barrel, but to the ledge of the earlier 'heart-shaped' bracket flange (Fig. 24.13). It is 13 in long x 2 in wide x $\frac{3}{8}$ in thick. Its curved support stay is c14½ in long formed of $\frac{1}{2}$ in square section.

Fig. 24.16 Right-side running-board central bracket, bolted to the boiler plate beneath the horizontal section. The cut off remains of the earlier bracket are to the rear of the boiler feed-pump.

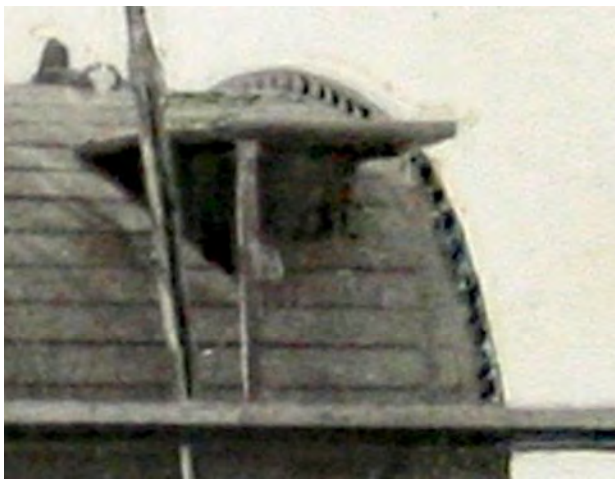
Fig. 24.17 Driver's seat from 1857 photo.
[Fig. 8.1 - detail]

The seat, probably of oak, was restored in 1961. It measures 20 in long and 16 in wide, and is $1\frac{3}{8}$ in thick. Its sides have been rounded off. When first preserved, the seat had just one vertical iron support at its leading end, which was secured on to the running-board. However subsequent photos taken in the 19th century and throughout the 20th century all show a second matching support at its rear end. The iron supports are 18 in high, $1\frac{1}{4}$ in wide and $\frac{1}{4}$ in thick.

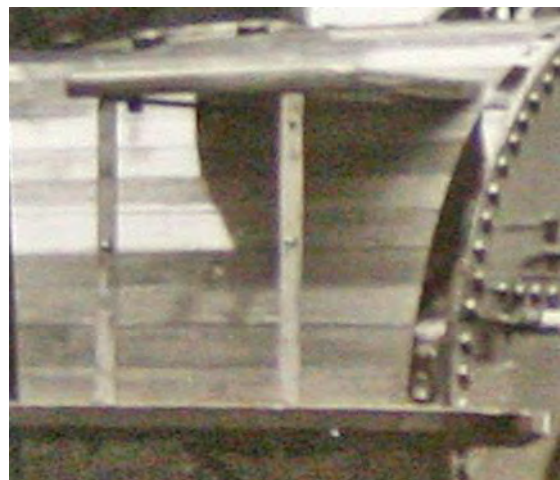
Fig. 24.18 Detail of driver's seat as restored in 1961.
[NRM Historic photos file, 812 R-175-3]

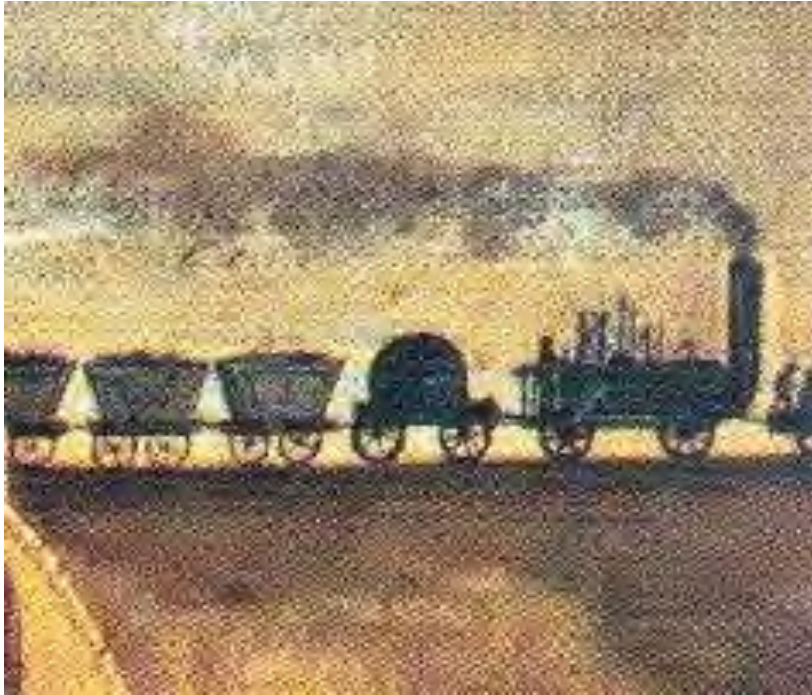
Fig. 25.4 Early Stephenson locomotive converted to a return-flue boiler, showing separate tenders for coal and water.

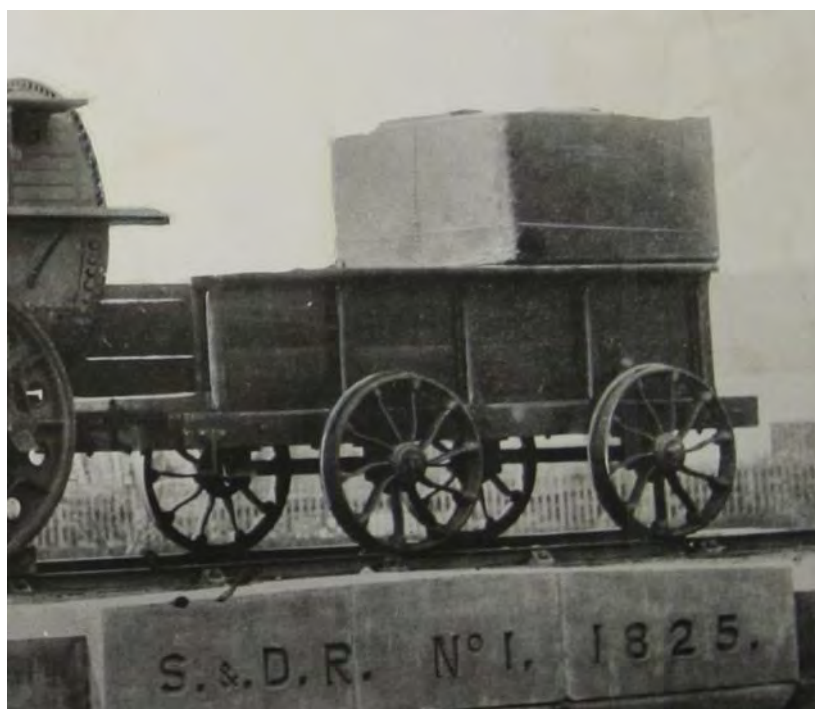
Fig. 25.7 The newly-made replica tender shortly after being placed onto the plinth outside North Road Station, Darlington
[NRM, York HQ Photos. Box 9, 1065 & x35789 – (detail)]

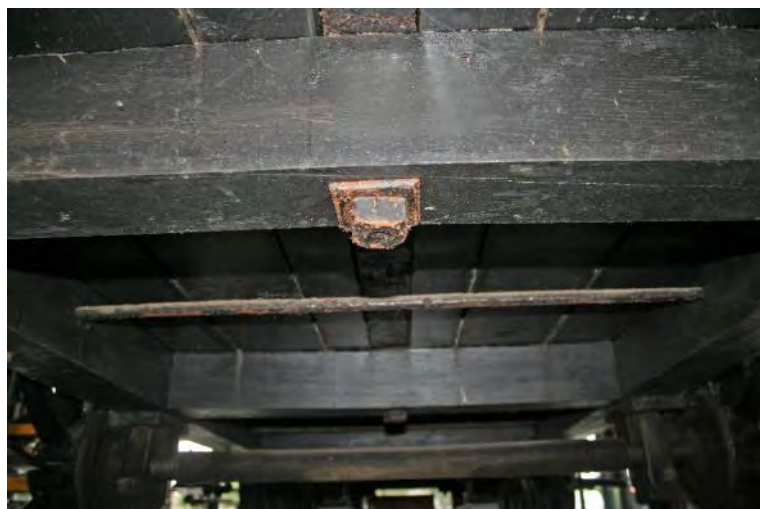
The length of the frame, over buffers, is 10 ft 4 $\frac{3}{8}$ in, and the vehicle's wheelbase is 4 ft 9 in. The two longitudinal exterior beams forming the sides of the frame are 4 $\frac{3}{4}$ in wide and 5 $\frac{3}{8}$ in high. Their buffer extensions at the front and rear are reinforced with 1 in wide wrought iron bands. The buffer centres are 22 in above rail level. The top outer corners are chamfered. Two further intermediate longitudinal beams are 4 $\frac{3}{4}$ in deep and 3 $\frac{3}{4}$ in wide. At the front and rear, transverse beams are fitted to complete the frame rectangle. These beams are 36 $\frac{3}{4}$ in long x 5 $\frac{3}{8}$ in high x 3 $\frac{1}{2}$ in thick. Two intermediate cross-members of similar section are inserted between the longitudinal inner beams to stiffen up the frame. Wrought iron tie-bars

are fitted to the frame. Three $\frac{3}{4}$ in diameter bars are fitted in the centre of the tender and at a separation of $47\frac{1}{2}$ in forward and rear. The frame is topped by boards forming the coal space which are $1\frac{3}{4}$ in thick and $7\frac{1}{4}$ in wide, with the exception of the centre board which is $10\frac{1}{2}$ in wide. The floor of the vehicle stands $24\frac{1}{2}$ in above rail level.

Fig. 25.10 Longitudinal and transverse frame members beneath the floor-boards of the coal-space (upward view)

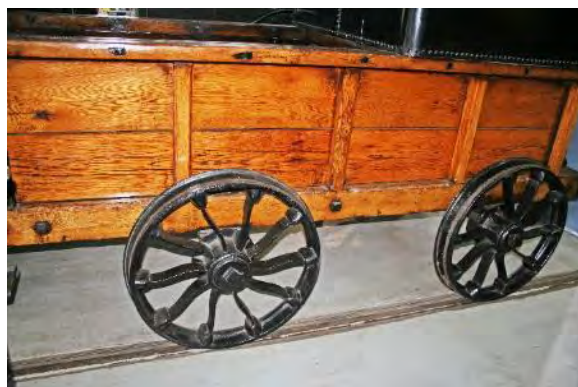
The two side-walls and the rear end are composed of two $10\frac{1}{2}$ in wide planks, one above the other, which are $\frac{7}{8}$ in thick. The side walls are 9 ft $2\frac{1}{2}$ in long and the rear end is 3 ft $2\frac{3}{4}$ in wide. Three vertical tie-bars of $\frac{3}{8}$ in diameter, on each side, pass through the side walls and are tightened beneath the frame. Five upright buttresses on each side, and two at the rear, support the side-walls on the outside. The buttresses, which are fixed by mortice and tenon joints, are $2\frac{3}{4}$ in wide, $2\frac{1}{4}$ in deep and 21 in tall. Both their outer corners are chamfered. The assembly is topped by a rail, $3\frac{1}{4}$ in wide, and $2\frac{1}{4}$ in deep running the full length of the side-walls. Its upper face is extended outwards using a cantilevered side timber which is 2 in thick and $3\frac{5}{8}$ in wide. The boarded area forms the coal space. It has a lip at the leading end, to retain the coal from vibrating forward, which is 3 in high and $2\frac{7}{8}$ in wide.

Fig. 25.11 External view of the left side

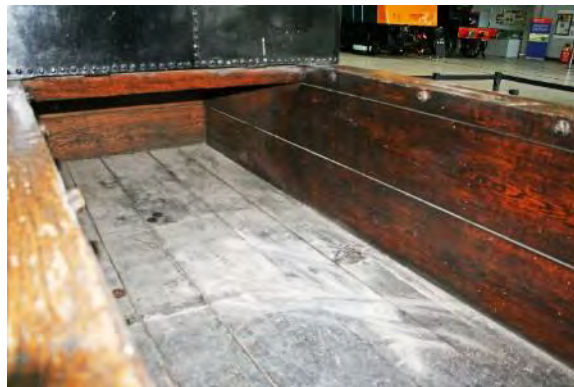
Fig. 25.12 Interior view of the left side.

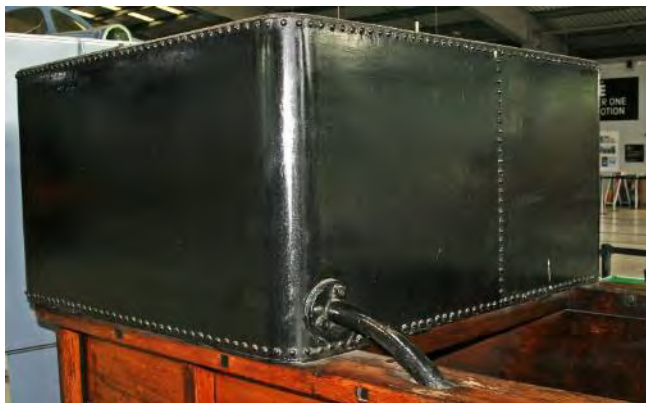
This replacement tank has no bottom plate, and its edges are supported on timbers above the side-wall top-rails. The tank-height is 2ft 3 in, its length is 4 ft and its width is 4 ft 7 in. Its rear face is flush with the outer face of the side-wall rails. It is made of 6-gauge mild steel. The top surface has a forward oval hole, with a maximum width of 15¼ in and maximum length of 13 in. Its centre is 10 in behind the leading edge. Its cover is wooden, topped by a steel plate. A rear hole on the tank top is 4¾ in diameter and covered with a wooden cover. Its centre is 10 in from the rear edge and 13 in from the left-side.

The water outlet is a 1½ in diameter pipe that leaves the front right corner of the tank near its bottom fitted with a 5 in diameter flange, some ⅜ in thick. The pipe is directed down diagonally to a brass regulator tap positioned adjacent to the tender's front right buffer.

The leading face of the tank is supported across the coal space by a cross-timber, the leading face of which is 2 in back from the front of the tank. The cross-timber is 2⅝ in thick and 3¼ in wide. Iron strap corner reinforcements in each of the rear corner spaces are 2¾ in wide and 3/16 in thick and are 10 in long.

Fig. 25.13 Front right view of water tank, showing supporting timber and outlet pipe.

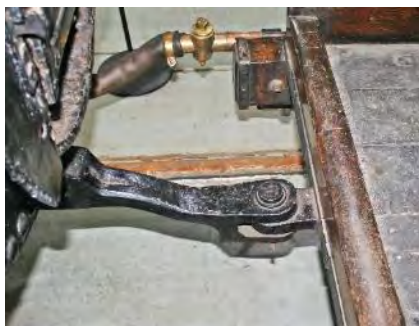
A 1 in thick wrought iron draw-bar runs the length of the tender. It is 3 in wide at the leading end and broadens out towards the rear to become 3½ in wide. The draw-bar eye is 2½ in wide, with a vertical pin of 1⅜ in diameter and a length of 4¾ in, and is secured by a split-pin and washer. The draw-bar eye at the rear has a 1½ in diameter hole into which a 1⅝ in diameter pin is inserted. The pin is 7 in long with an upper diameter of 1⅜ in.

Fig. 25.14 Leading draw-bar pin

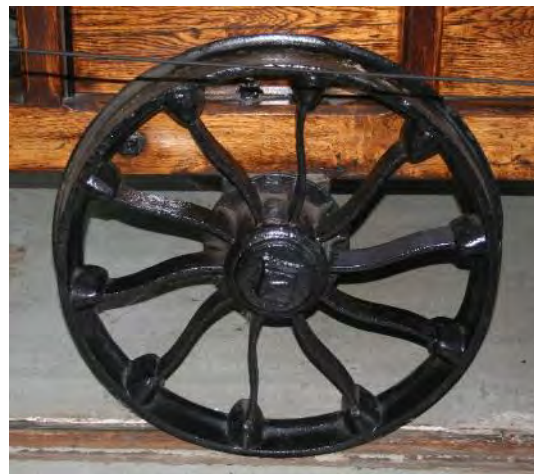
Fig. 25.17 Surviving wheel on No. 1's tender.

The wrought iron wheel-spokes are $\frac{1}{2}$ in thick and inserted into sleeves on the rim. The maximum width of the cast iron hub is $6\frac{1}{4}$ in, although to avoid the back of the wheels rubbing against the vehicles frame, spacer washers have been inserted between the hubs and the bearings. The wheels are bolted to the axles, which are thus threaded on their ends to receive the bolts. The $2\frac{1}{4}$ in A/F square-headed bolt-heads suggest that a thread diameter of $1\frac{1}{4}$ in was adopted. The back to back separation between wheels on each wheel-set is 4 ft $6\frac{1}{4}$ in. The axles are $2\frac{3}{4}$ in diameter, and are not reduced where fitted to the wheels.

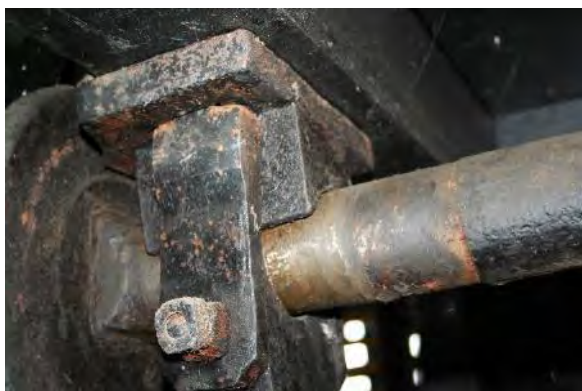
The four axle bearing assemblies are bolted to the side frames. Their side members are extended upwards through the side frames as threaded rods, secured by nuts at their tops. Each assembly has a 4 in long half-bearing on the upper surface of the axle, and a lower keep, with longitudinal bolts holding the assemblies together. The bearing assembly is topped by a $7\frac{3}{4}$ in long contact block, on which sits the inner longitudinal frame members. The vehicle is springless and track inequalities would have been taken up by the frame flexing.

Fig. 25.18 Rear left horn assembly.

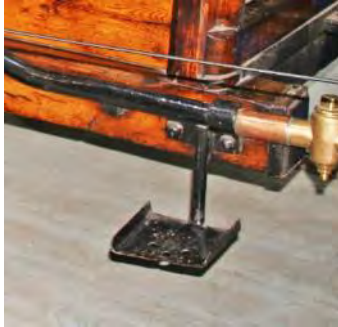
Wrought iron foot-steps are provided at the leading ends of the buffer arms on both sides of the tender, to which they are bolted. The step height is 4 in below the bottom of the frame and $15\frac{1}{2}$ in above rail height. The steps are $6\frac{1}{2}$ in deep and 7 in wide.

Fig. 25.19 Right-side footstep

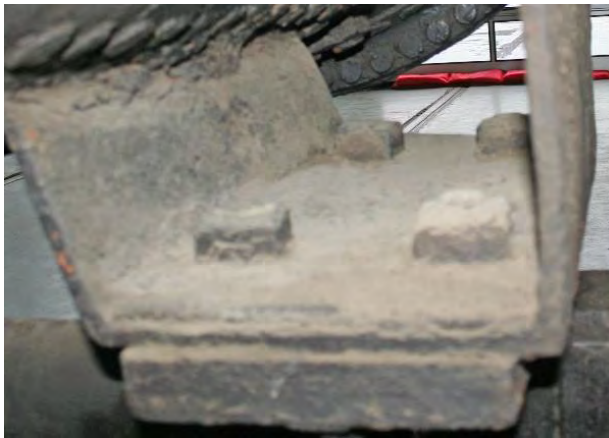
Fig. 26.1 Front right boiler bracket showing 1892 plate inserted onto its base, thereby covering evidence of lubrication access.

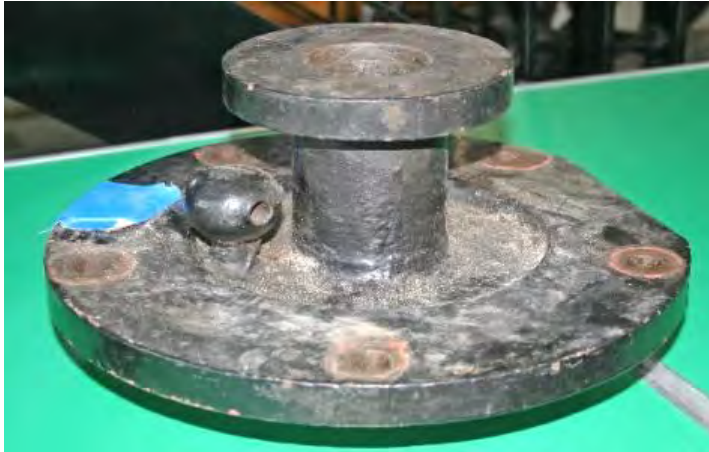
Provision was made for oiling the pistons within the cylinders using an access hole in the cylinder covers. A removable spigot is inserted into the access hole when operating.

Fig. 26.2 Cylinder cover with lubricant feed hole (fitted with a spigot).

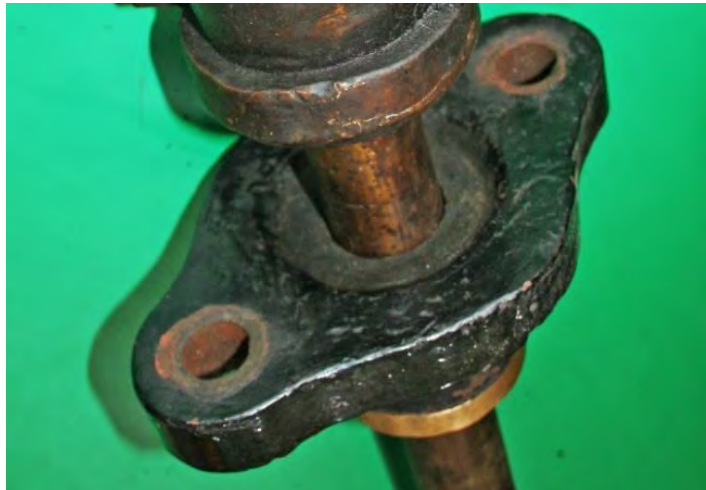
Provision for lubricating the piston rod bushes, was made using collar reservoirs which allowed lubricants all-round penetration with the piston rods themselves.

Fig. 26.3 Piston rod bush with collar lubricant reservoir.

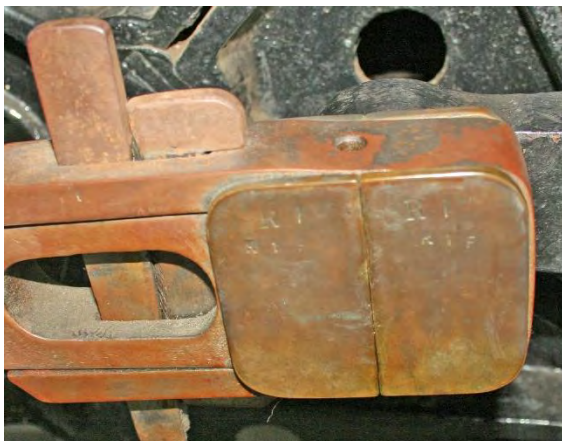
Other lubrication entry points remain *in situ* for some of the motion components such as coupling rods and valve rocking shafts.

Fig. 26.4 Coupling rod crank bearing with lubrication access hole.

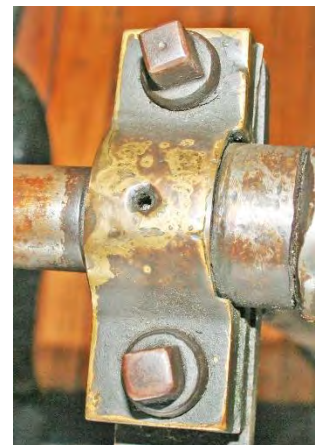
Fig. 26.5 Valve rocking shaft with lubrication access hole.

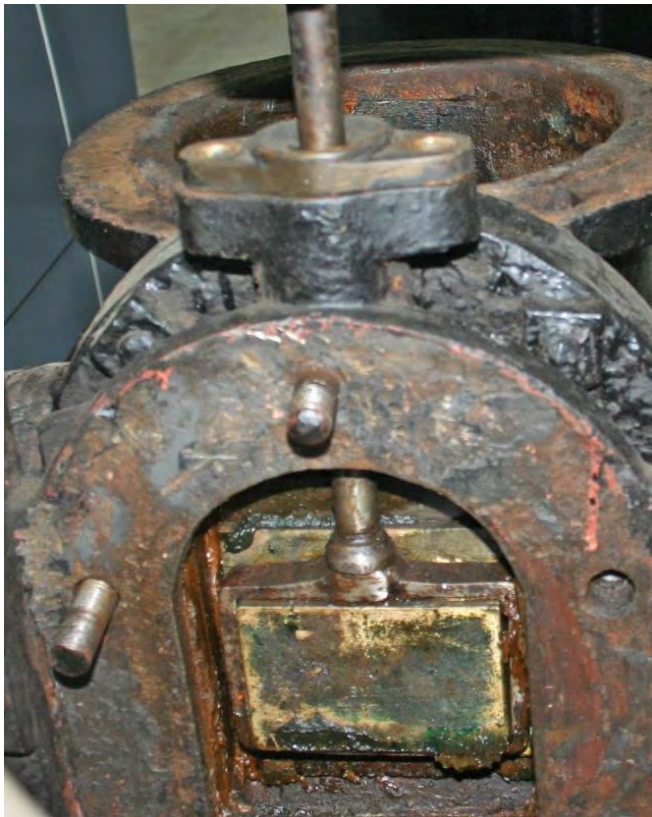
Fig. 26.6 Valve rod bush with collar reservoir for oiling the bush and valve chest.
